PROPOSAL

FOR THE DEVELOPMENT OF THE CANOE CLUB LANDS AND PROPERTY

CALEB GROUP

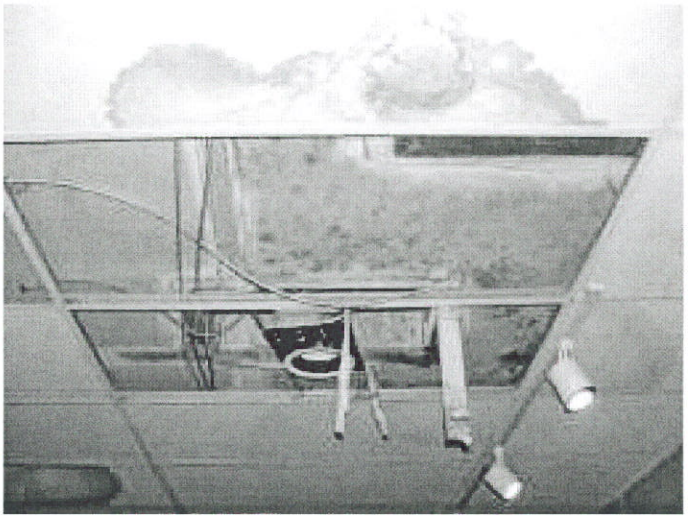
Photo 5: Visibly water damaged ceiling tile (lower ceiling) and wallboard (upper ceiling). Note visible black mould growth on wallboard.

- Conduct a detailed intrusive investigation to identify all water damaged or mould contaminated building materials. Extensive visible mould growth has been identified on wall and ceiling surfaces, flooring, furnishings and structural members such as wood wall studs in the basement , wood subfloors and the apparent wood roof decking. It is expected that hidden mould growth is present behind baseboards, walls, above ceiling tiles and wallboard ceilings and below subfloors. The lower four feet of all walls should be investigated in areas in which flooding has occurred and the ceilings of all areas should be investigated as a minimum.

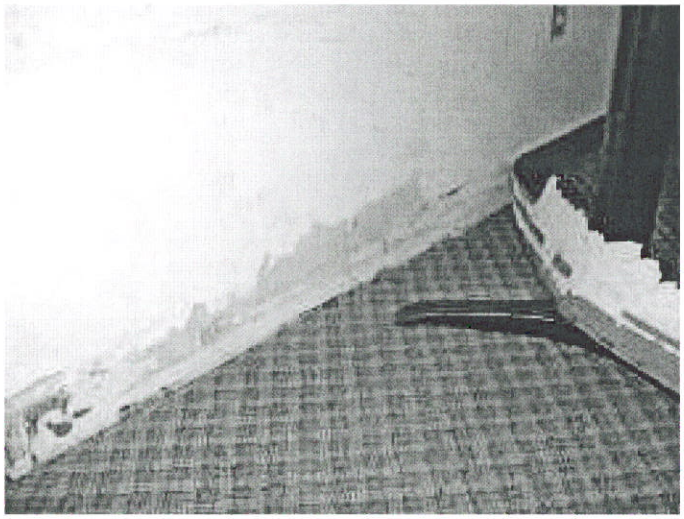
Photo 7: Visible black mould growth along base of wallboard wall in a non-water damaged area of basement. Indicates non-flooded areas affected by high moisture levels in building.

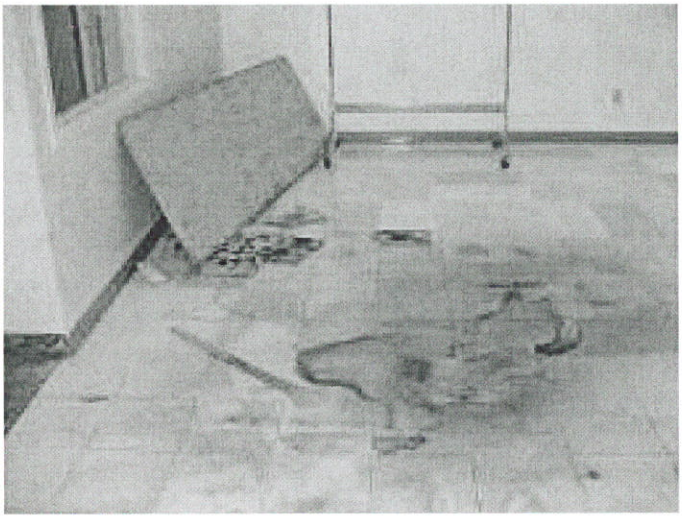
Photo 9: Water damaged area in classroom area at NW corner of basement. Note visible mould growth on ceiling tiles located on floor.

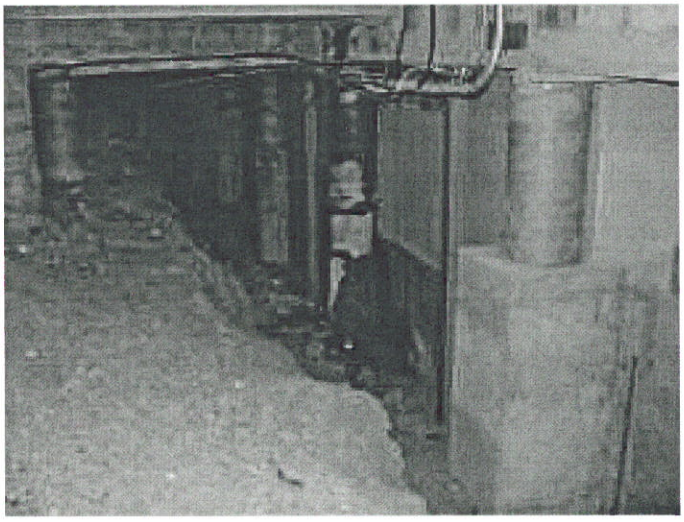
Photo 11: Basement storage room showing earth wall construction. Area shown is located near where foundation is undermined. Soil was wet at this location.

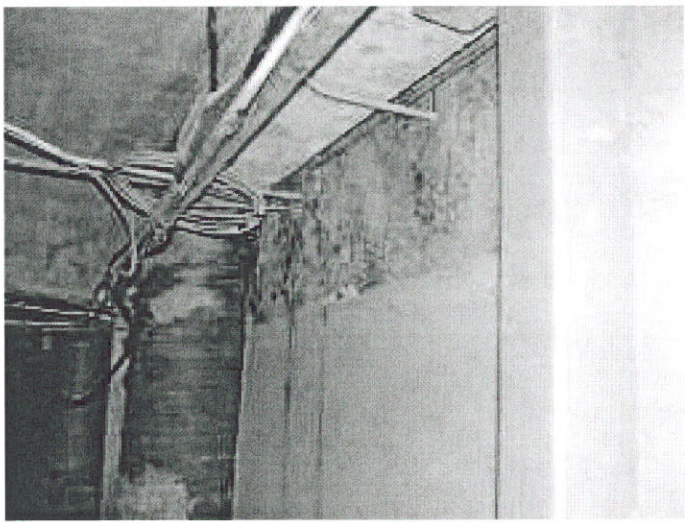
Photo 12: Wallboard wall adjacent to earth wall in basement. Note water damage on column due to roof leak and visible mould growth.

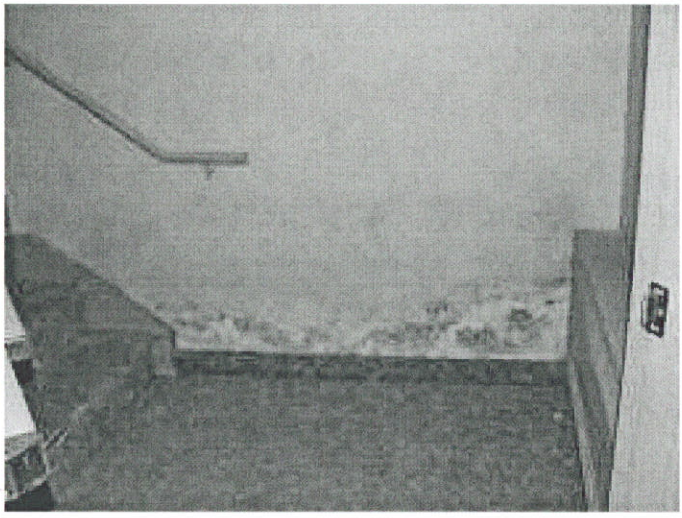
Photo 13: Visible mould growth on wallboard at base of basement stairs.

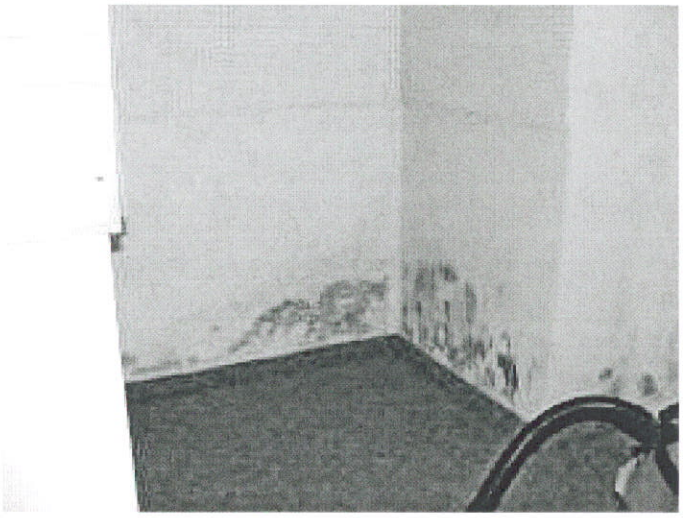
Photo 14: Visible mould growth on wallboard in basement office area.

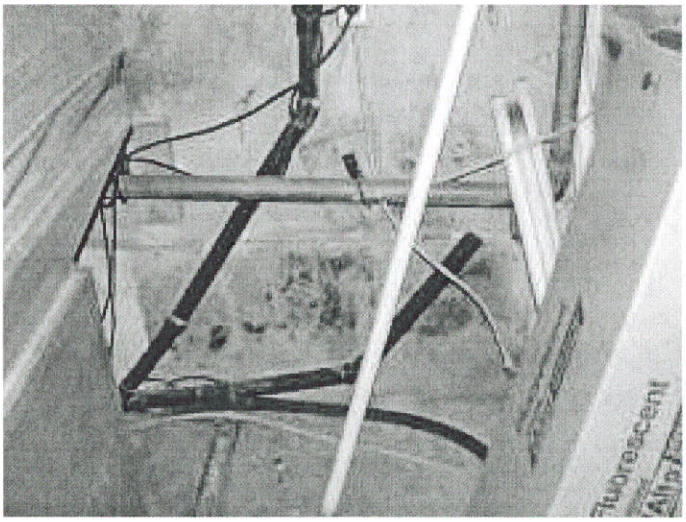
Photo 15: Visible mould growth on wallboard in sub-basement furnace room.

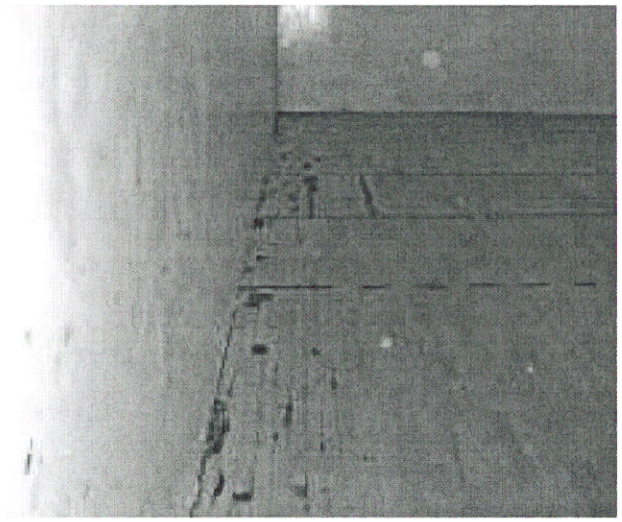
Photo 16: Visible mould growth and wet boards in sub-basement racquetball court. Visible mould was also observed on surface of cement walls in this area.

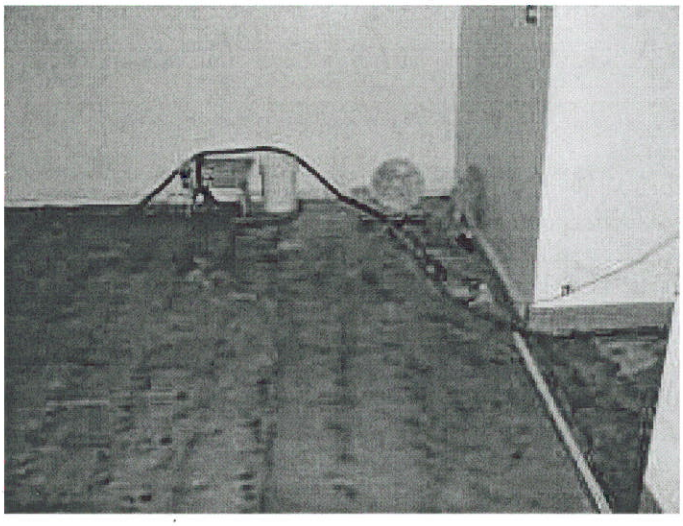
Photo 17: Wet wood subfloor in sub-basement near sump pit. Adjacent hardwood floor was severely damaged and carpets were heavily water stained.

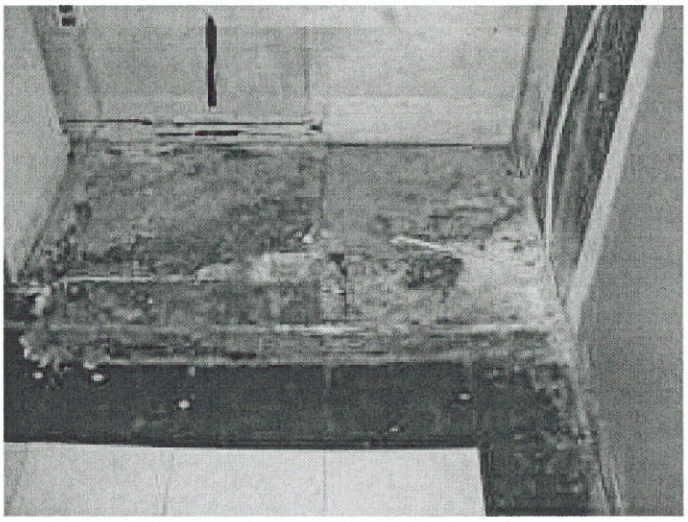
Photo 18: Multiple layers of suspect vinyl asbestos floor tile and roll flooring in main floor lounge area.

- The presence of asbestos associated with the wallboard or plaster finishes would be expected to affect all renovation activities. Where wallboard with asbestos texture coat is to be disturbed, it should be removed under modified Type 1 abatement conditions in accordance with Provincial Guidelines. If the building is to be demolished, asbestos containing texture coat associated with the wallboard will not likely have to be removed.

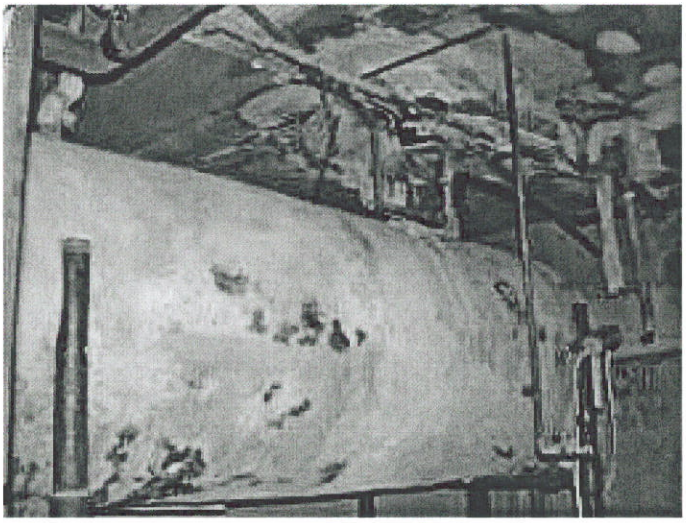
Photo 19: Exposed suspect asbestos containing mechanical insulation in steam mechanical room. Note water damaged ceiling and mould growth.

- If found to contain asbestos, the mechanical insulation in the steam room mechanical area should be removed. It was observed in very poor condition with the potential for asbestos fibres to be exposed to the air. Debris was also present on the floor of the room.

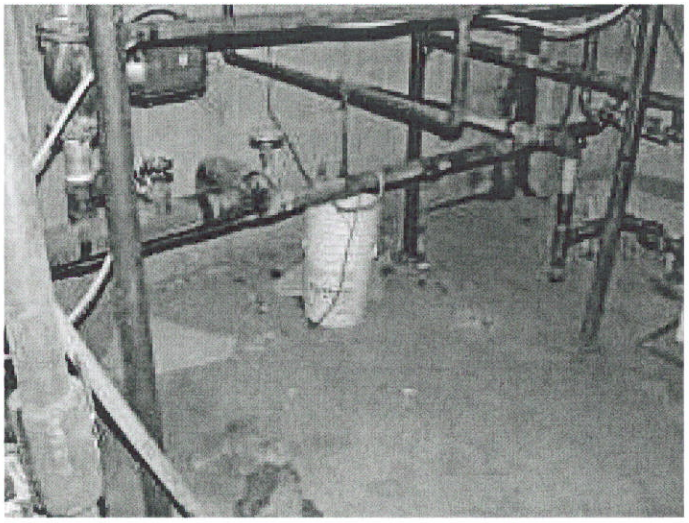
Photo 20: Suspect asbestos debris present on floor of steam mechanical room.
