Agenda – Executive Policy Committee – December 4, 2009

Item No. 5 **Request for Financial Assistance –**
Le Musée de Saint-Boniface Museum
(St. Boniface Ward)
eFile PR-9.3

CONDITION ASSESSMENT

THE GREY NUNS' CONVENT CONDITION ASSESSMENT

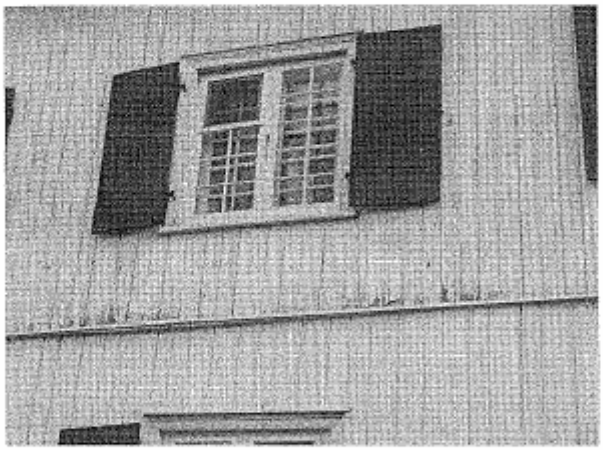
Task 1: Repainting the exterior wood siding and trim boards

Existing Condition: The exterior of the building is divided vertically into two sections by a horizontal drip board and flashing. The lower vertical siding was replaced with new siding in 1995; the upper siding predates the lower siding. Paint is peeling on the siding located above the metal flashing and the metal drip is in good condition. In some areas its slope is not sufficiently pitched downward to the exterior of the building.

Preservation Scope of Work: Work to include all exterior wood surfaces including siding, all exterior window and door trim, all dormer window trim, all soffits and fascia, bell tower trim and siding, all porches and flashings. The approach is to scrape and sand all exterior surfaces by hand to remove all loose paint. Window sash was repainted off-site two years ago and will not require re-painting but window sills need treatment and all exterior window and door trim as identified below is to be repainted. Ensure all surfaces are smooth and dry before re-painting. Colour to match existing. Any rotted boards to be identified to Architect before proceeding. Paint to be as specified – ensure undercoat applied on all bare wood first. Provide two final coats on all finished surfaces. With a continuous, level, horizontal sawcut at the base of the second storey siding, immediately above the mid-level flashing, remove 10mm of the upper siding to prevent wicking of water up into the boards from moisture at the flashing. It is imperative that the metal flashing behind the siding is not cut or nicked in the process.

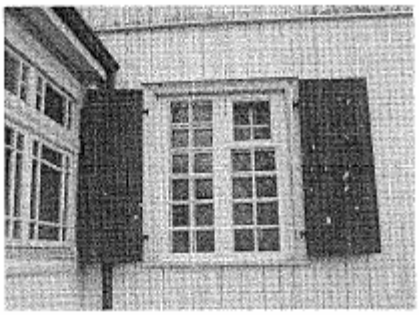
Task 2: Repainting the exterior Shutters

Existing Condition: Each window in the existing building has a pair of heavy shutters hung on painted steel pins. In most cases, the hinges are in reasonable condition, but where shutters are missing, the hardware is also gone. The wood at the shutters appears to be in reasonable shape. About a third of the shutters are crooked and all shutters have loose or peeling paint.

Preservation Scope of Work: Work to include all exterior shutters. The existing paint on the shutters is peeling away in large strips with much of the existing wood in bare condition. It was considered that scraping and sanding would not provide long-term protection for the shutters. Therefore, the approach is to remove the shutters from their demountable hardware and chemically dip-strip each unit to ensure complete removal of all paint. Ensure that each shutter is numbered and returned to the same location. Ensure the dip-strip method is the gentlest possible. Assume that 35% of the shutters will need to be rebuilt as original using the existing materials. In addition, assume that 10% of the shutters will need to have new materials to match the material type, detailing and form of the existing. Repaint the shutters as specified with an undercoat and two finish coats. Retain a colour sample from the existing shutters to confirm colour. Ensure that all support brackets are secured to the walls and that the shutters are installed level and perpendicular.

A test sample of a shutter should be evaluated after the dip and strip method. If the results are too abrasive on the wood surface, an alternative method should be tested – this method should be similar to Task 1 above with scraping, sanding and priming preparation prior to painting.

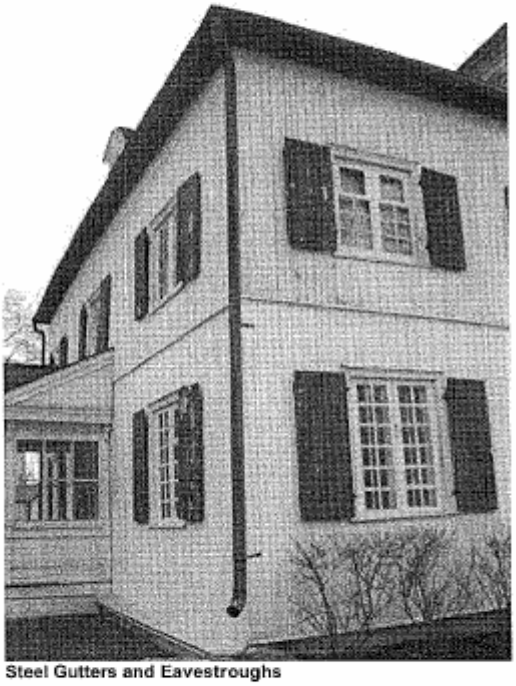
Steel Gutters and Eavestroughs

Existing Condition: The existing painted steel eaves troughs are about 200mm wide with 150mm downspouts located at the corners of the building. Both troughs and downspouts are deteriorated, causing leakages and they will soon be causing problems with the roof/wall interface. The eaves troughs date from a 1960's renovation and are short half-pipe sections of metal and many joints. With downspouts installed at the corners of the building only the centre of the eaves trough is highest at the centre of the façade, falling to the edges. The bow created is out of place with the heritage lines of the building – as well the slope does not appear to provide adequate drainage as evidence of overflowing and leaks is observed. The troughs are sagging in some locations, paint is peeling, and downspouts do not drain on to splash pads.

Preservation Scope of Work:
A new eaves trough and downspout system is required. With a new water control system, the provision of a number of downspouts around the perimeter of the building will increase the flow of water and reduce the visible slope in the trough. We suggest two options for a re-created eaves trough:

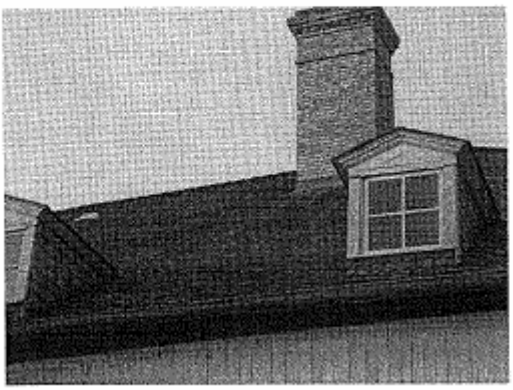
Cedar Shingle Roof

Existing Condition: The existing cedar shingles were replaced in 1985. Since that time, several dozen have come loose and fallen off the building. There is no evidence that we observed of interior damage; however, maintenance of the shingles is imperative.

Preservation Scope of Work: The task for this work is to inspect the roof for locations of missing shingles and replace with saved units or new to match existing. Assume replacement of 50-75 shingles throughout all areas of the roof.

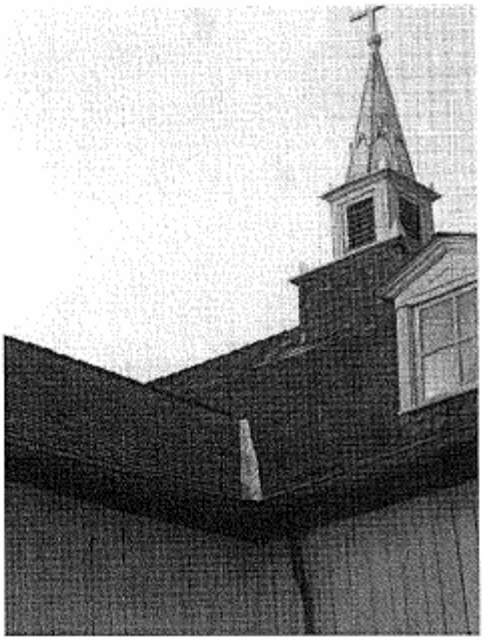
Roof Valley

Existing Condition: On drawing A-3, we have indicated an area of severe ice damming that was noticed during our winter observation. Located at the southeast junction of the two building volumes, ice damming was not observed in other locations at that time but could be expected at other similar locations.

Preservation Scope of Work: The scope of work for this component is to add heat tracing in the valley of the east elevation as shown on A-03. This is one of the only ice dam problem areas and is very hidden from public view. As this ice dam could contribute to the deterioration of the exterior siding below and the interior fabric, it is recommended to install approximately 10m of heat trace into this valley. Contractor to ensue the installation is as innocuous as possible. As good preventative maintenance, measure, we recommend heat tracing of all valleys and eaves.

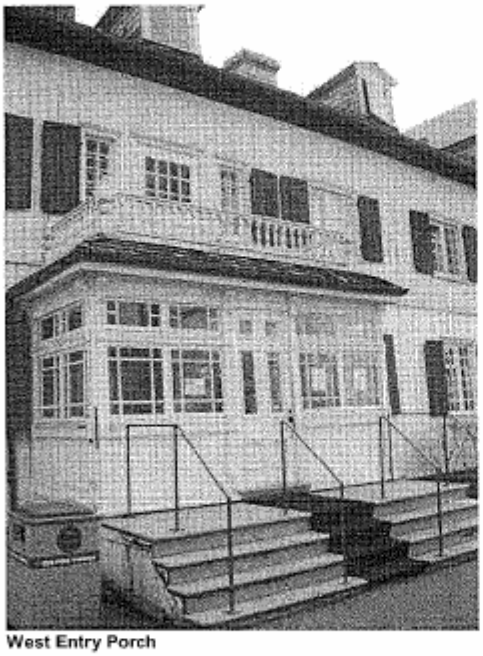
West Entry Porch

Existing Condition: The enclosed entry porch is in need of wood repair, window repair, and new paint. The skirt around the porch is rotten and structural replacement and repair is required. The existing painted steel railings are an inappropriate component of this heritage entry. Stair treads and stringers need repair. The upper roof and upper balustrade at the second floor deck are in good shape.

Preservation Scope of Work: In the 1995 restoration, the upper part of the porch was restored including a new roof and balustrade. The roof had leaked for many years and had caused deterioration of the lower structure, but there wasn't sufficient funding to repair the lower structural fabric. In this restoration, we are proposing to return and rebuild significant portions of the porch in keeping with its heritage character below the roof line. Please see attached documents prepared by Manitoba Historic Resources in Appendix A.

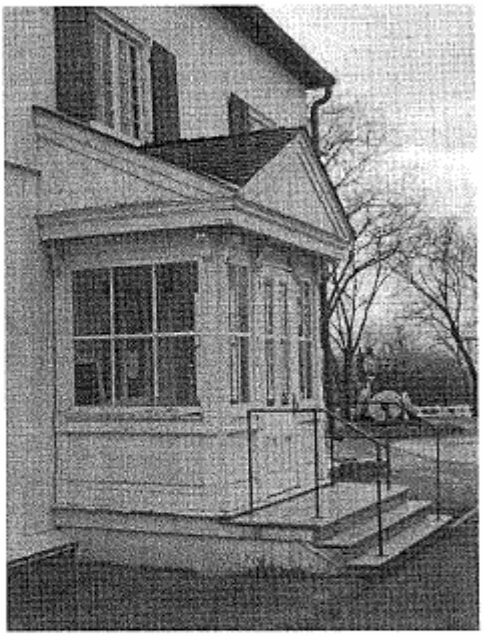
North Entry Porch

Existing Condition: There is evidence of rotten wood components of the existing north entry porch. Architectural details are in need of restoration, and paint is both loose and/or stripped in a number of places. Again the railings here are out of place with the character of the building. Stairs and building skirt are in reasonable condition with minor cosmetic repair required. This porch is in better condition than the West Entry Porch.

Preservation Scope of Work: In addition, we are planning to replace several base casings at the main level of the landing on the north elevation Entrance Porch. See Item 4 on Drawing A-01 for location. The work involves the removal of several horizontal trim boards above the steps that have rotted through. Work would be to recreate the profile and wood type, paint and replace.

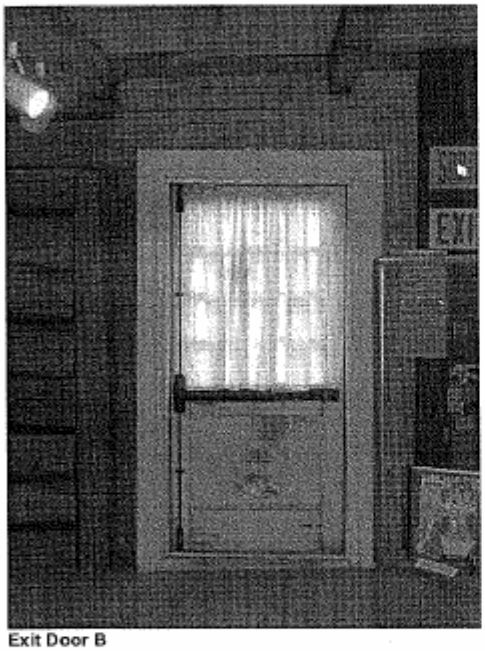
Exit Door B

Existing Condition: Three locations of exit doors are in need of replacement. This door shown below is representative of the condition of the three doors listed here that need to be addressed. They are poorly weather sealed and rotting from moisture leakage in the panelling.

Preservation Scope of Work: The scope of work for this component is to rebuild or replace three exterior doors. Doors A and B are located on the heritage envelope and are exit doors from the interior space. They are simple stile and panel designs and likely not original. They have deteriorated over the years and no longer function well to provide exit or weather protection functions. An interior layer of Lexan protection has been added to the original single glazing taking away from the heritage character of the door. Doors C are new doors added to the north protection lobby and need replacing with new exit hardware.
