Report - Standing Policy Committee on Public Works - June 10, 2003

Item No. 5 Installation of Speed Humps on Haney Street South of Eldridge Avenue File ST-5

Re:	Installation of Speed Humps on Haney Street South of Eldridge Avenue
For Submission To:	The Standing Policy Committee on Public Works
Original Report Signed By:	J. A. Thomson, P. Eng. Director of Public Works
Report Date:	May 15, 2003
Recommendations:	That the speed humps on Haney Street be studied for another winter season before making any conclusions about future installations on oil treated/chip-seal roadways with ditch drainage.

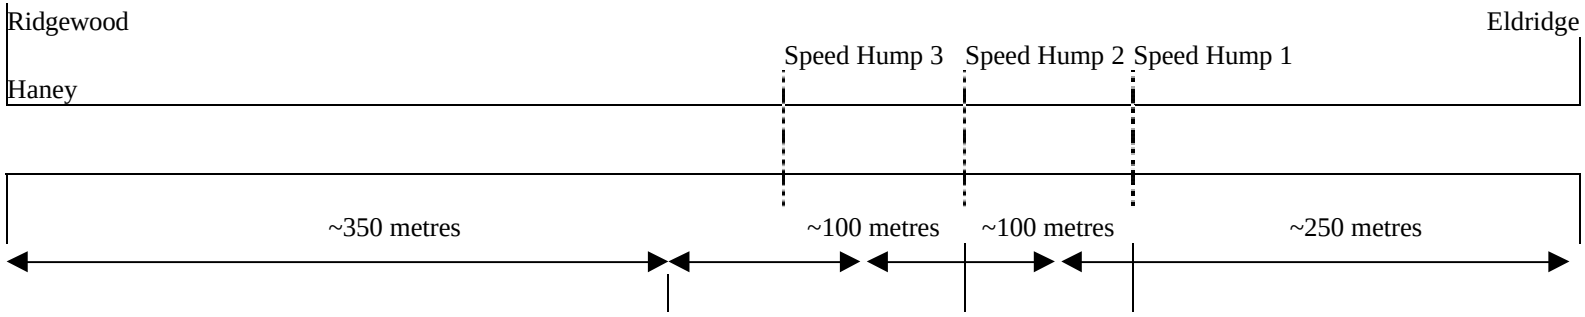
[1] 3 speed humps were installed on Haney Street in September 2002 at the following locations: (i) approximately 250 metres south of Eldridge Avenue, (ii) approximately 350 metres south of Eldridge Avenue, and (iii) approximately 450 metres south of Eldridge Avenue.

[2] Location 1 is approximately half way between Eldridge Avenue and the first speed hump south of Eldridge Avenue.

[3] Location 2 is approximately half way between Speed Hump 2 and Speed Hump 3.

[4] Location 3 is approximately half way between Ridgewood Avenue and the first speed hump north of Ridgewood Avenue.
