Summary Report

Winnipeg Discoloured Water Investigation

Prepared for
City of Winnipeg

December 2013

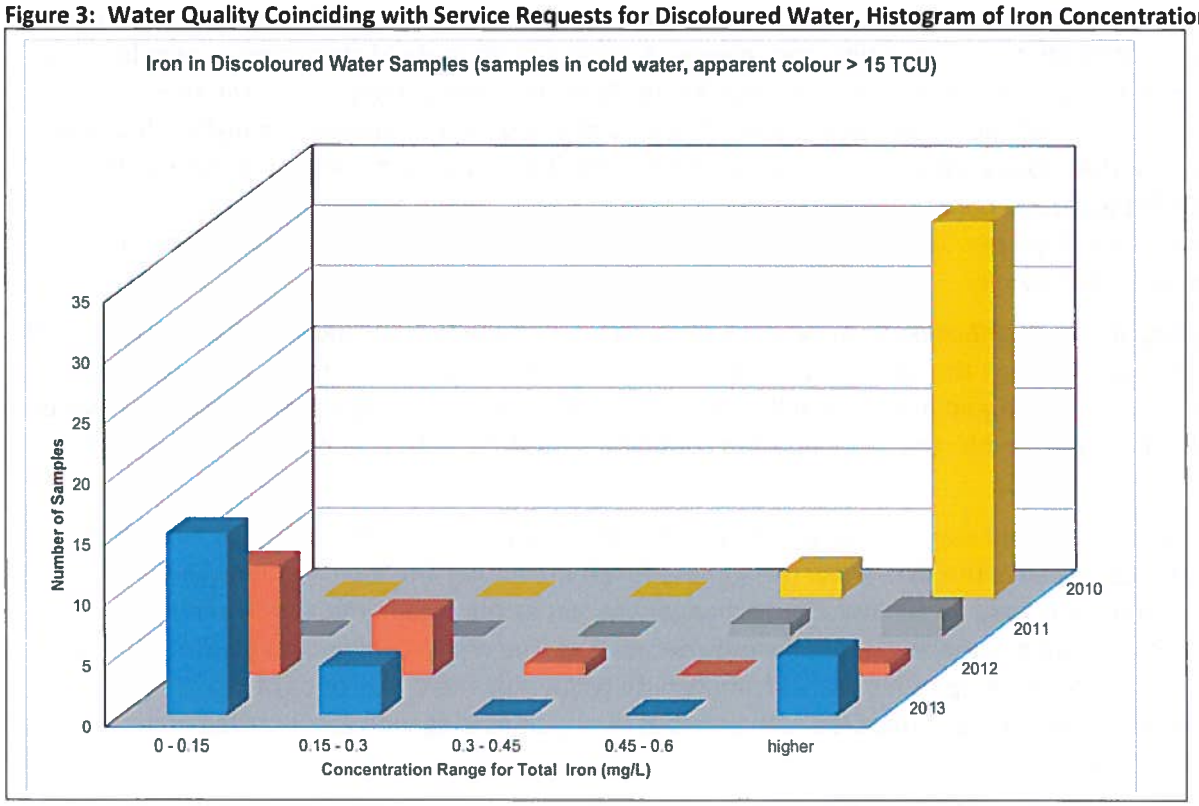
Figure 3: Water Quality Coinciding with Service Requests for Discoloured Water, Histogram of Iron Concentrations

Sampling at the Customers' Taps: In response to discoloured water service requests, the City was able to collect water quality information at several customer locations for a wide range of water quality parameters including metals, bacteriological quality, disinfectant residuals, turbidity and colour. Four years of data were collected and results for the bacteriological quality and disinfectant residuals were good in these samples. For samples with higher levels of turbidity and colour, these data reveal that iron and/or manganese were measured at concentrations high enough to be detected by the customer as discoloured water (see Figure 3, Water Quality Coinciding with Service Requests for Discoloured Water, Histogram of Iron Concentrations and see Figure 4, Water Quality Coinciding with Service Requests for Discoloured Water, Histogram of Manganese Concentrations). Also of note is a trend of decreasing iron and increasing manganese levels in the more recent customer samples collected in response to service requests. Although manganese may be dominating the discoloured water occurrences, iron is also an important contributing factor.

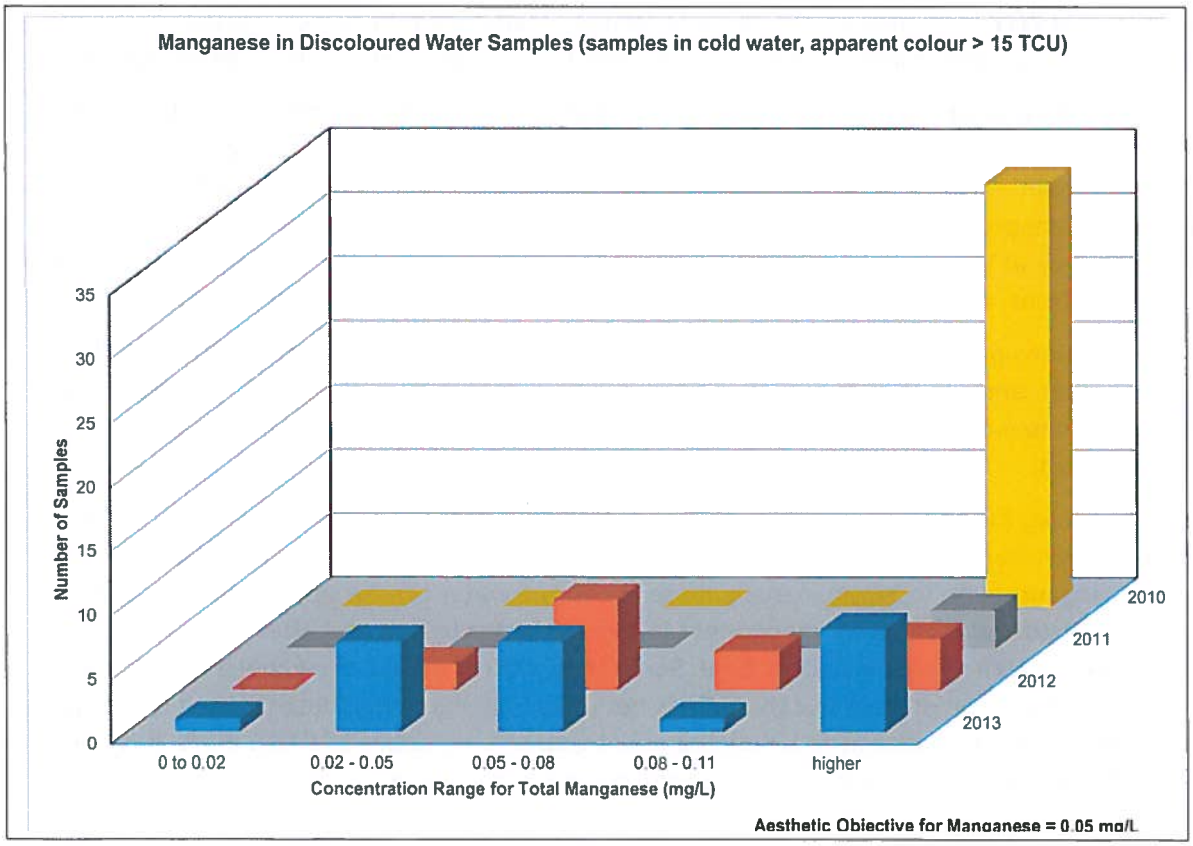
Figure 4: Water Quality Coinciding with Service Requests for Discoloured Water, Histogram of Manganese Concentrations

Based on the experience of others, manganese concentrations of 0.02 mg/L and higher can cause a problem through its accumulation and release as water travels in the distribution system (per the Guidance for the Treatment of Manganese, Water Research Foundation, 2013). The release concentration that causes discoloured water to be noticed or a problem may be higher than 0.02 mg/L, and therefore a treatment objective of 0.015 mg/L provides some margin of safety. The new treatment objective recommended for manganese in treated water leaving the plant is less than the Aesthetic Objective for manganese of 0.05 mg/L identified in the *Guidelines for Canadian Drinking Water Quality*.

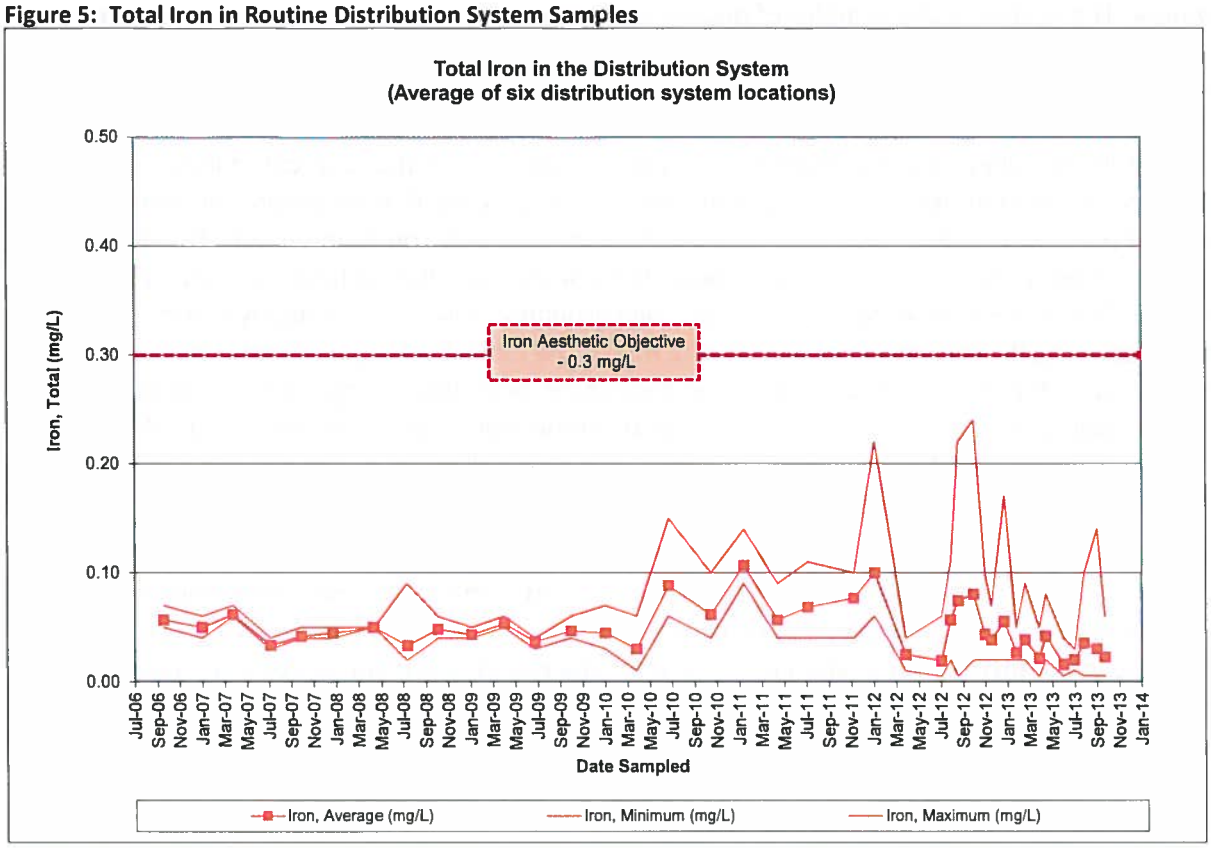
Figure 5: Total Iron in Routine Distribution System Samples

Sampling in the Distribution System: Prior to the startup of the WTP in 2009, unfiltered water had been running through the City's distribution system for over 80 years. To understand the longer term impacts of iron and manganese that has collected in the distribution system, historical water quality data collected by the City as part of routine distribution system sampling were analyzed (see Figures 5 and 6).

The levels of iron and manganese reported from distribution system samples in this data set are of importance: because the data show manganese levels increasing and indicate that the discoloured water complaints may be attributable to manganese, yet at the same time, iron levels in distribution system samples are significantly decreasing. The water quality data confirm the trend from the customer samples (collected from service requests). The occurrence of discoloured water was worse in 2013 when compared with previous years, coinciding with the increase in manganese concentrations.
