*Summary Report*

# Winnipeg Discoloured Water Investigation

Prepared for
**City of Winnipeg**

December 2013

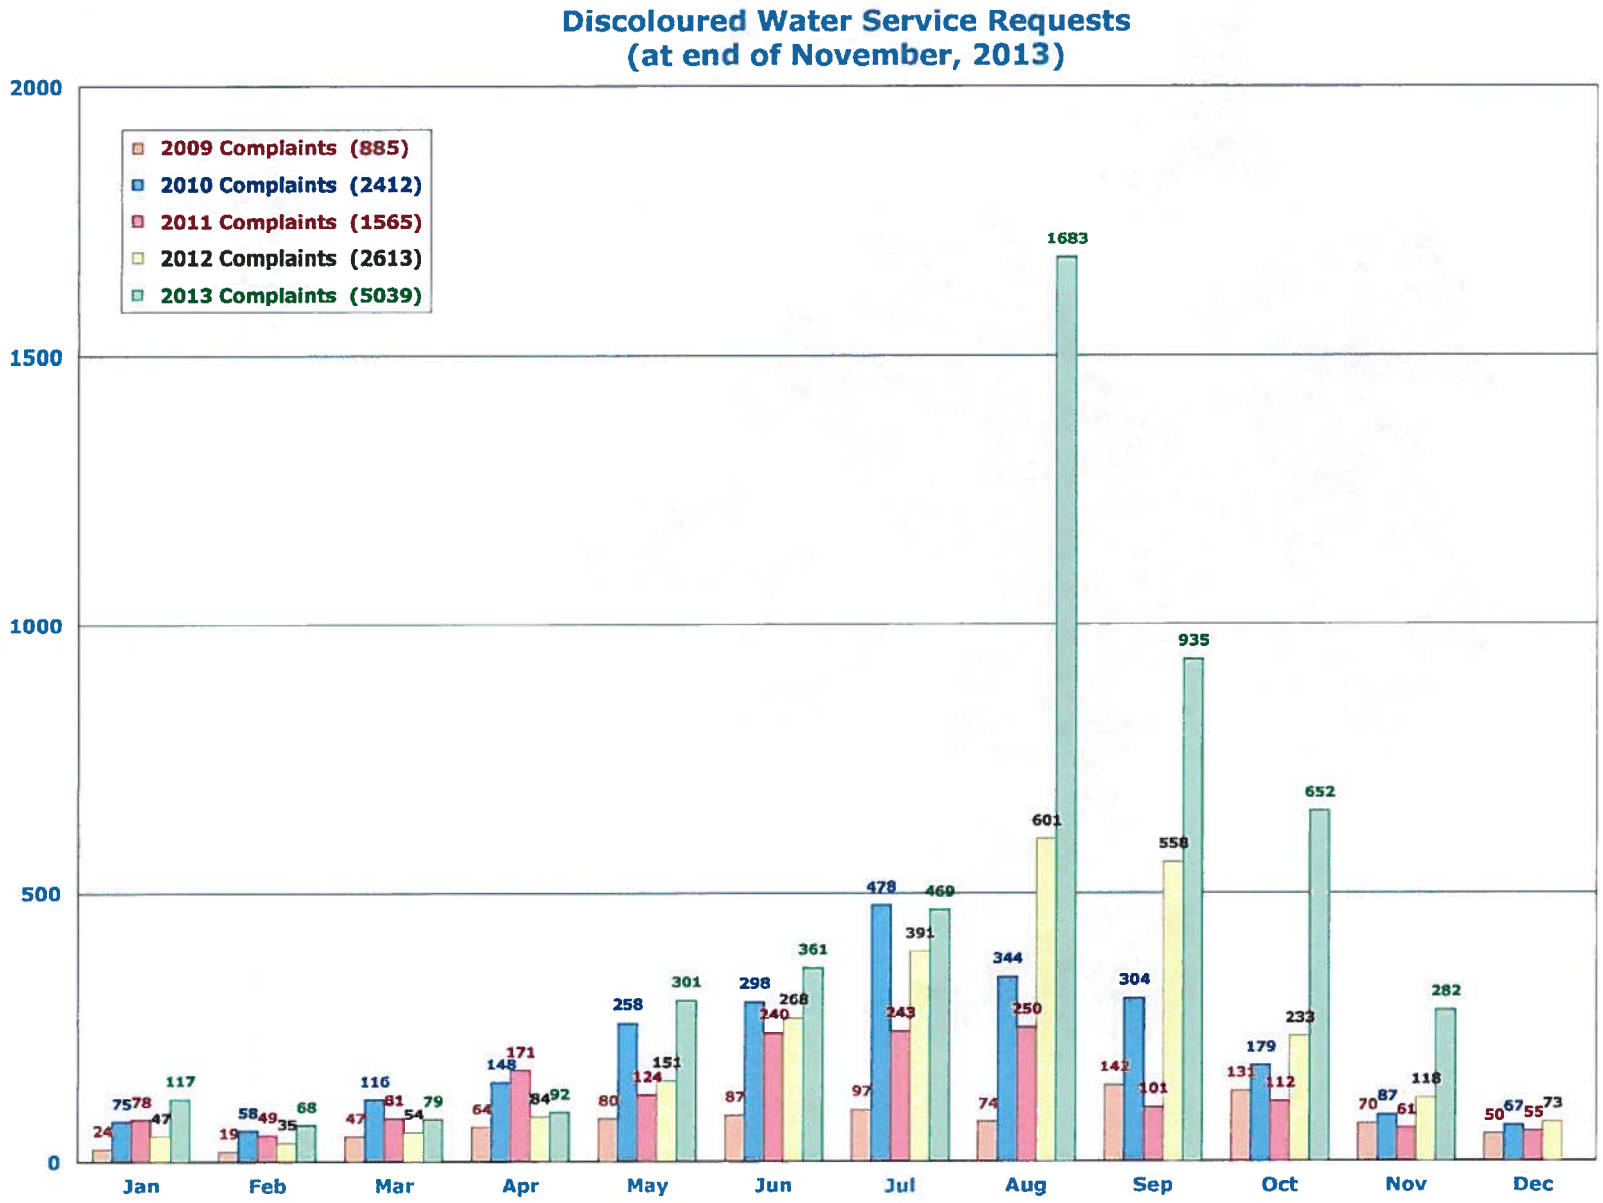
**Figure 1: Monthly Discoloured Water Service Requests**

The City has tracked customer calls regarding "dirty water" for many years. Historically, these have primarily been due to the disturbance of sediment and buildups in water mains. Before the commissioning of the new water treatment plant (WTP) in December 2009, this sediment was attributed to the buildup of dead algae and other compounds present in the unfiltered water supply. With the start of the new WTP, the quality of the water entering the distribution system has improved, however service requests referencing "discoloured water" occurred. The number of service requests per year has varied (see Figure 1, Monthly Discoloured Water Service Requests), and following a decline in the 2011 – and after two years of operation with the new WTP – an increase in the number of service requests for discoloured water occurred in 2012. This study was initiated in 2012 to address the occurrence, control and prevention of discoloured water in the Winnipeg distribution system.

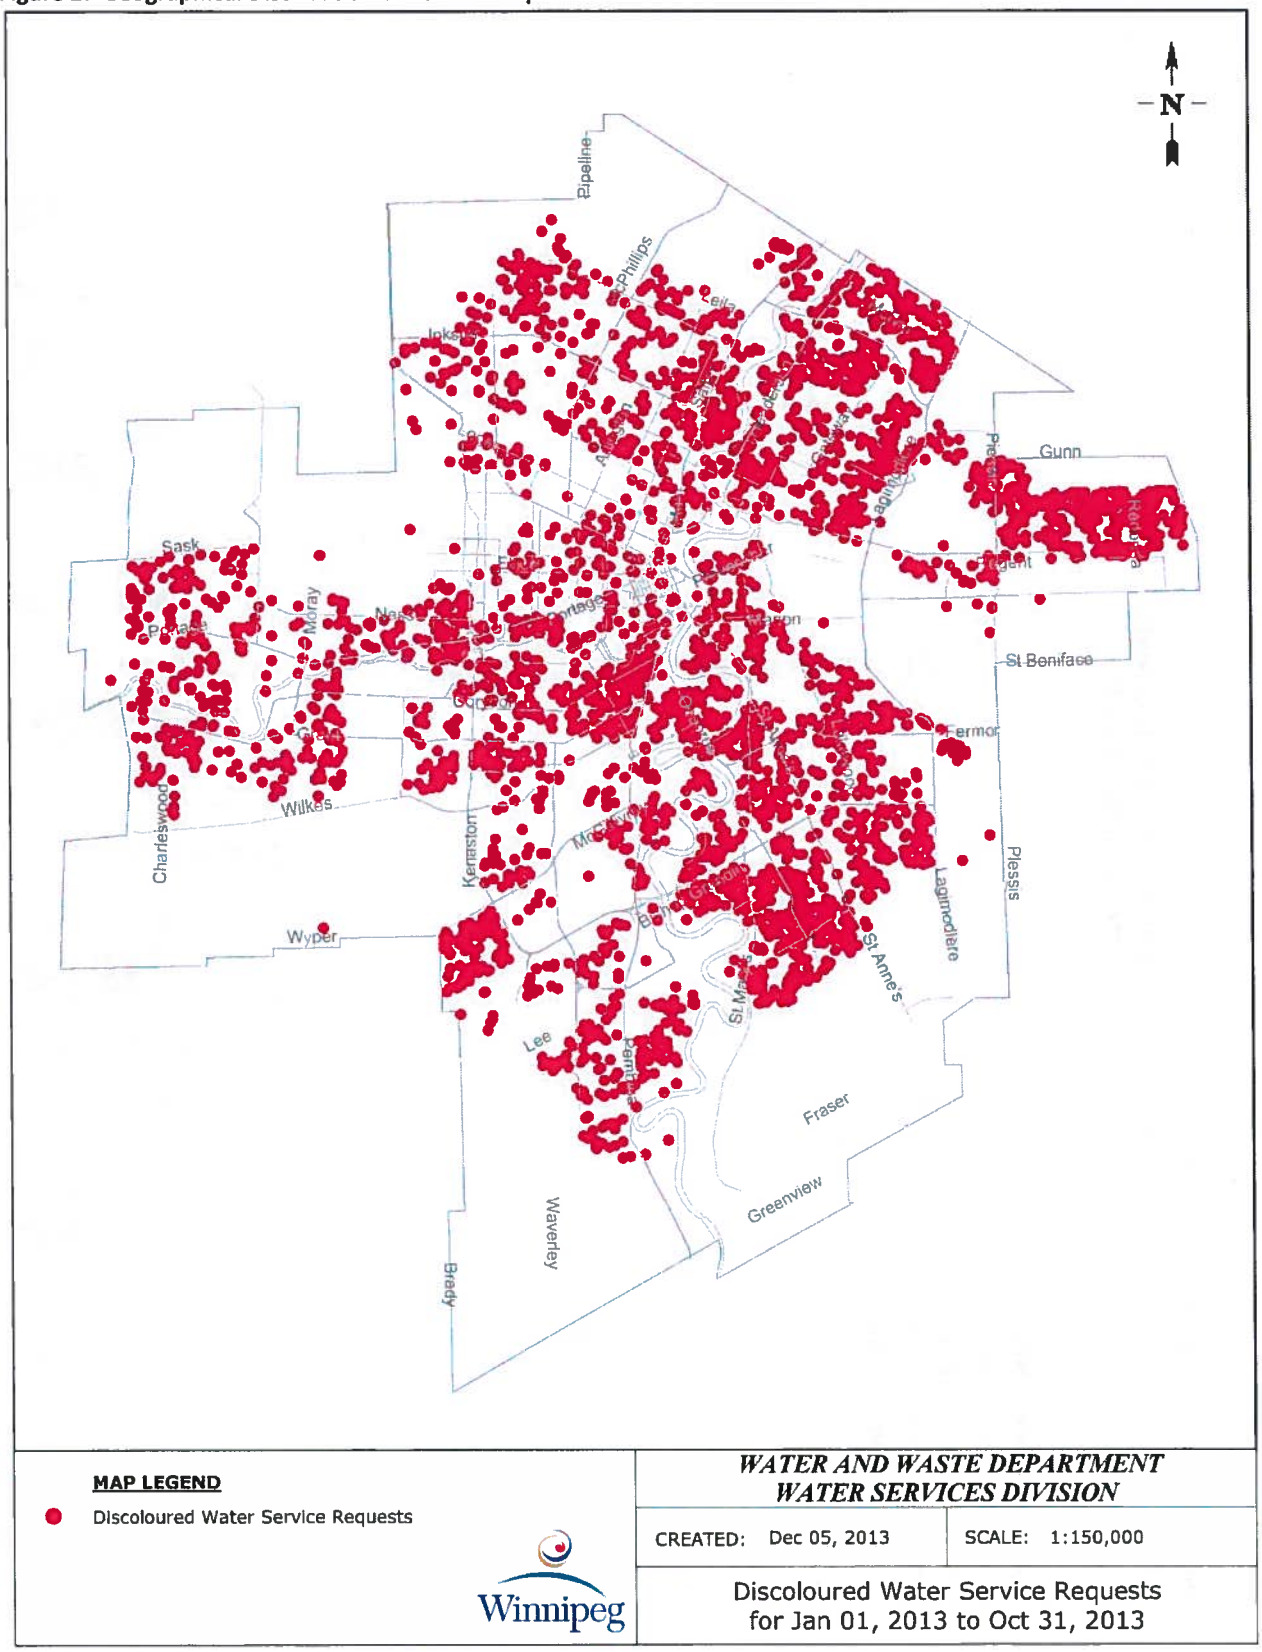
**Figure 2: Geographical Distribution of Service Requests for Discoloured Water**

Discoloured water refers to observations of yellow, brown or black water in solution and water samples are generally free of large sediment, although some smaller pieces of suspended matter may be seen. Observations of discoloured water are seasonal in nature, peaking in late summer (see Figure 1). Some, but not all, discoloured water events could be attributed to construction and maintenance activities, such as water main servicing in the distribution system. The occurrence of discoloured water is widespread in the City, although some areas experience more events than others (see Figure 2, Geographical Distribution of Service Requests for Discoloured Water).

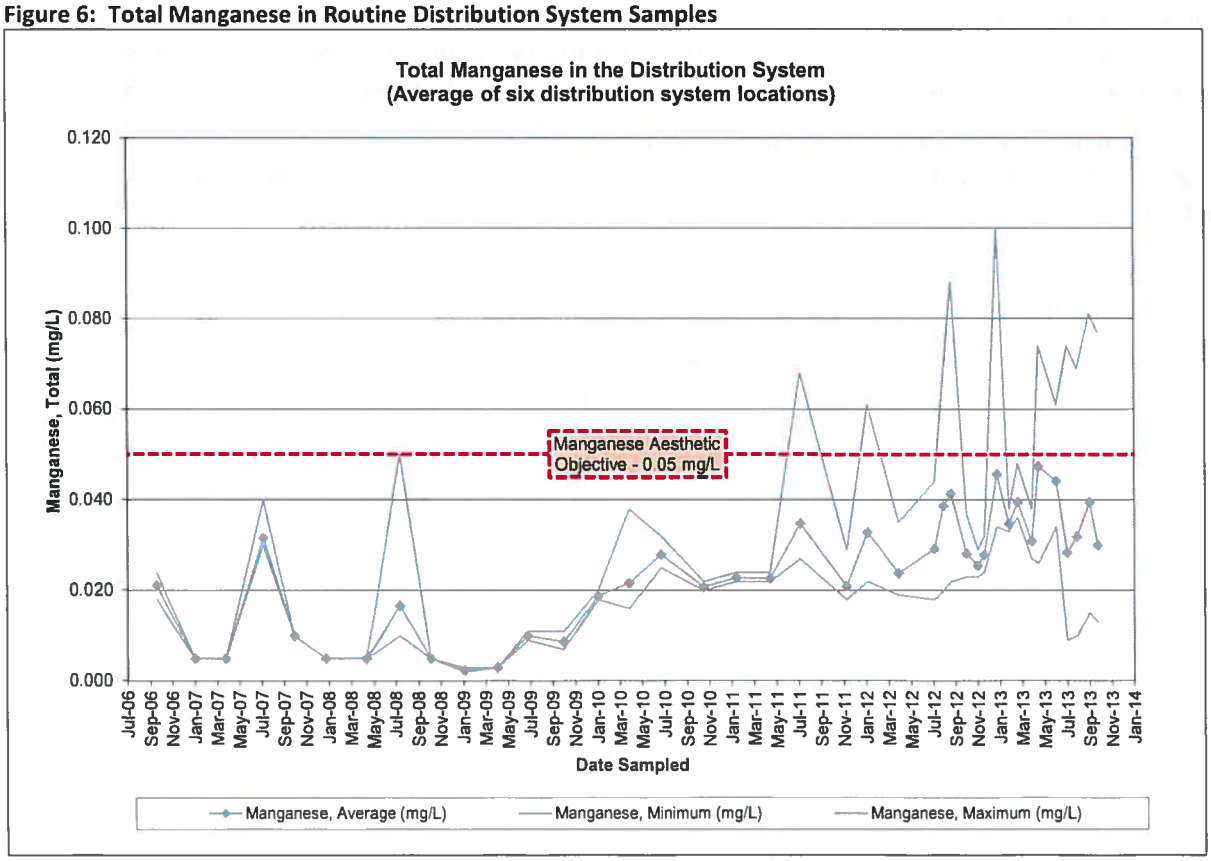
***Sampling in the Distribution System:*** Prior to the startup of the WTP in 2009, unfiltered water had been running through the City's distribution system for over 80 years. To understand the longer term impacts of iron and manganese that has collected in the distribution system, historical water quality data collected by the City as part of routine distribution system sampling were analyzed (see Figures 5 and 6).

The levels of iron and manganese reported from distribution system samples in this data set are of importance: because the data show manganese levels increasing and indicate that the discoloured water complaints may be attributable to manganese, yet at the same time, iron levels in distribution system samples are significantly decreasing. The water quality data confirm the trend from the customer samples (collected from service requests). The occurrence of discoloured water was worse in 2013 when compared with previous years, coinciding with the increase in manganese concentrations.
