Appendix E: Myrtle Conservation Assessment, 2016

OUTREACH SERVICES - SITE VISIT REPORT

Name of Institution: City of Winnipeg Archives
Address: 50 Myrtle Street
Contact Name: Sarah Ramsden sramsden@winnipeg.ca
Contact Info: (204) 986-2983
Date of Visit: August 9, 2016

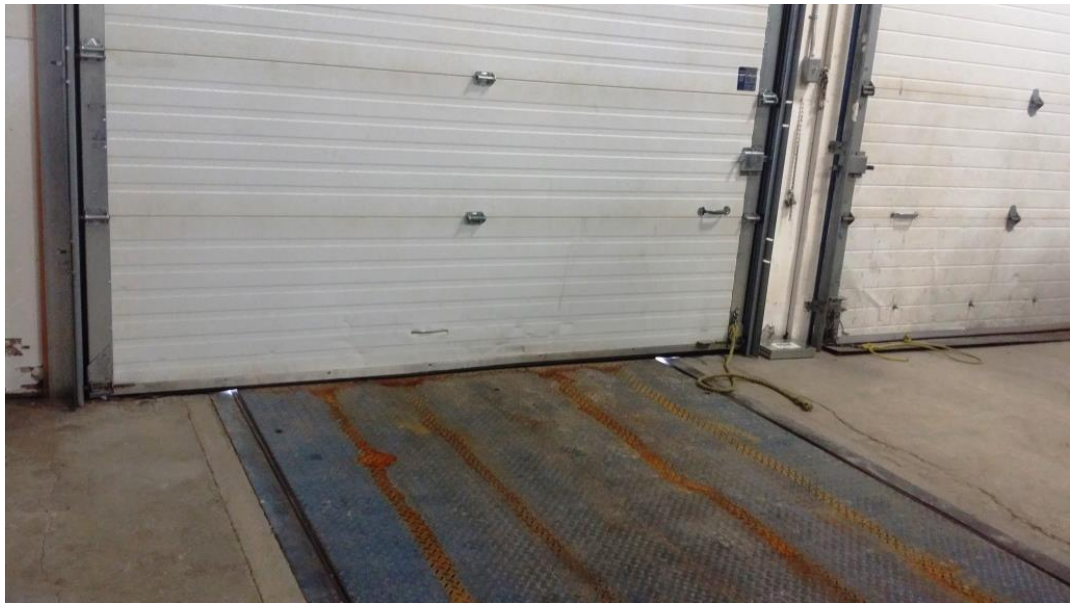
Overhead Door

Water blows in under one of the overhead doors during extreme weather and has resulted in rusting of the metal loading apron. Daylight can be seen under the door when closed, which often indicates that the weather stripping requires adjusting or replacement. However, when viewed from outside, deterioration of the wall underneath the door is visible. It is recommended that the exterior wall surrounding this door be repaired as it not only allows water infiltration but permits rodent access through the gaps and holes in the metal apron.

Repair the exterior wall surrounding the damaged overhead door to prevent water infiltration and rodent access.
