WEST KILDONAN LIBRARY

BUILDING CONDITION ASSESSMENT, HERITAGE ASSESSMENT, CODE COMPLIANCE REVIEW, & FEASIBILITY STUDY

Winnipeg, Manitoba
March 2024

Prepared for:
The City of Winnipeg

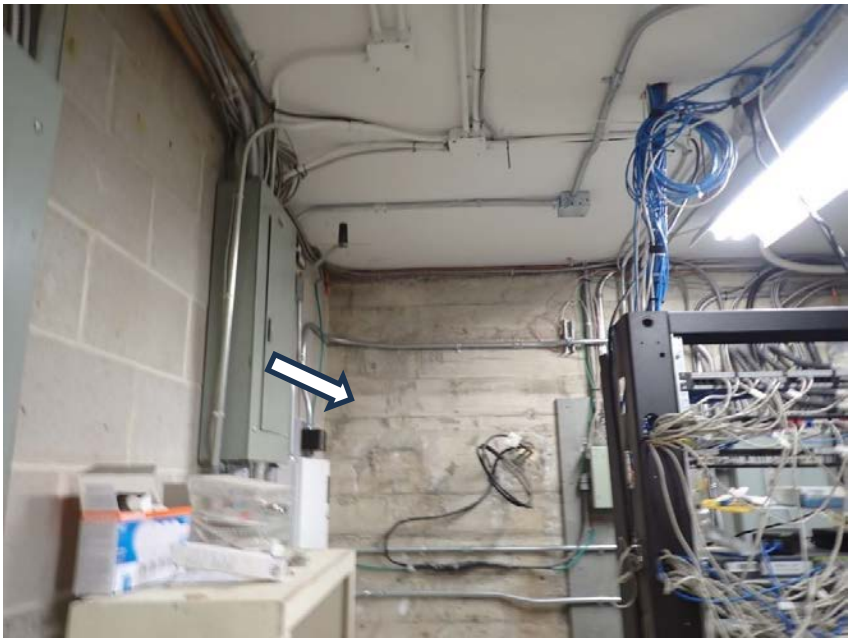
Photograph #8:

East foundation wall in good condition where visible.

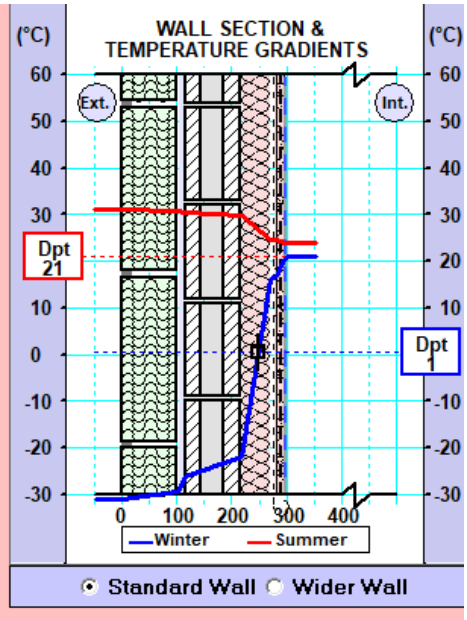
The construction of the exterior walls below the transom windows is shown, from exterior to interior, as Tyndall Stone cladding, a finger space with mortar fill, 4" concrete block back-up, 2" of rigid insulation, vapour barrier, and 5/8" plaster board. Both the nominal 4" standard pipe section columns and the HSS girt, project to the back of the Tyndall Stone cladding or project into it.

Simple linear thermal resistance modeling suggests the wall's gross thermal resistance to be approximately RSI 1.46 (R8.3). Note the dew point in the insulation which confirms that the block back-up will remain below freezing and experience condensation and/or frost accumulation on its interior facing surface during the heating season. This increases the potential for freeze-thaw damage and produces conditions within the wall assembly conducive to biological growth.

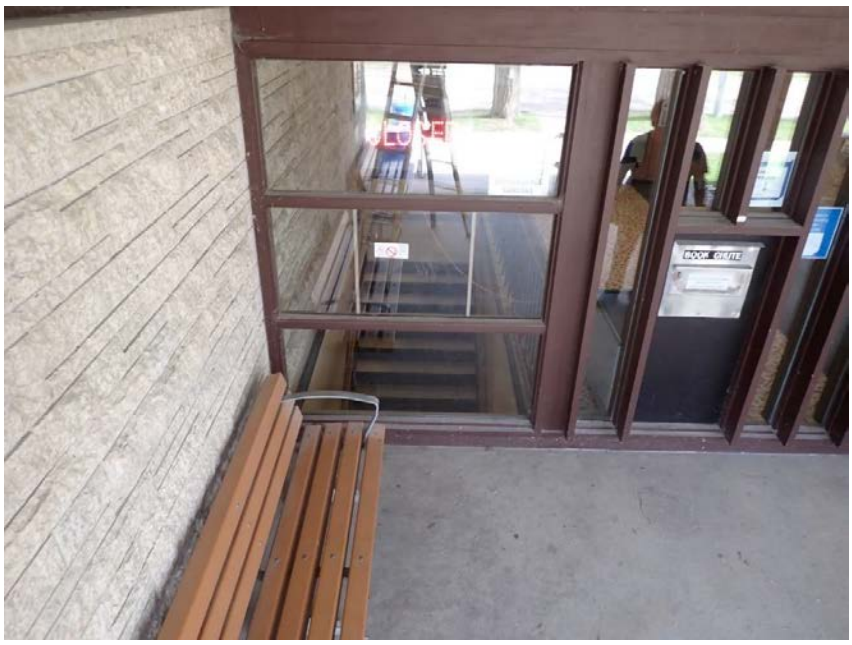
Photograph #19:

- As shown in Photograph No. 19, a feature of the original architecture is to have the stone cladding at the entrances project through to the interior. According to the drawings, a vertical 2x4 interrupts the stone and provides a connection to the window framing. Still, this detail represents a significant thermal bridge.

Stone clad wall extends from exterior to interior.

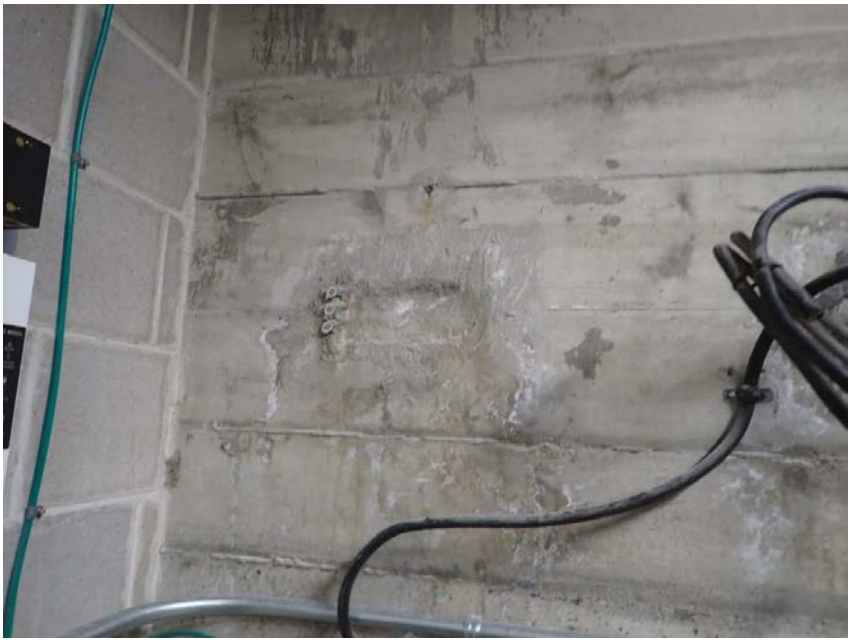
Water staining on west foundation wall.

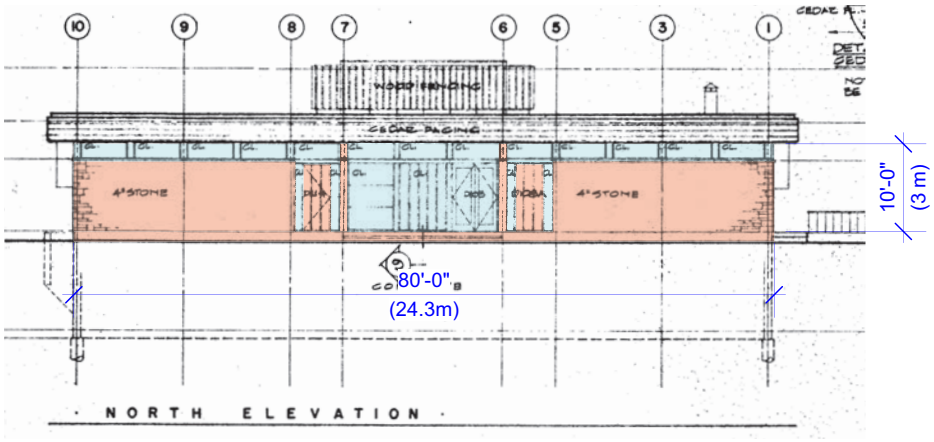
North Elevation:
Exposing Building Face: 82 sqm
Unprotected Openings: 31 sqm
% of Unprotected Openings: 38%
Ratio = 8.1 : 1

Recommendations: On the north side of the library, fire shutters or sprinklers could be added at the unprotected openings where they exceed the maximums allowed. However, the expense for this would be great, and as stated above, the adjacent building is not close to the library. It is unlikely that the amount of unprotected openings in the building would be reduced / infilled. The exterior facades are heritage protected.

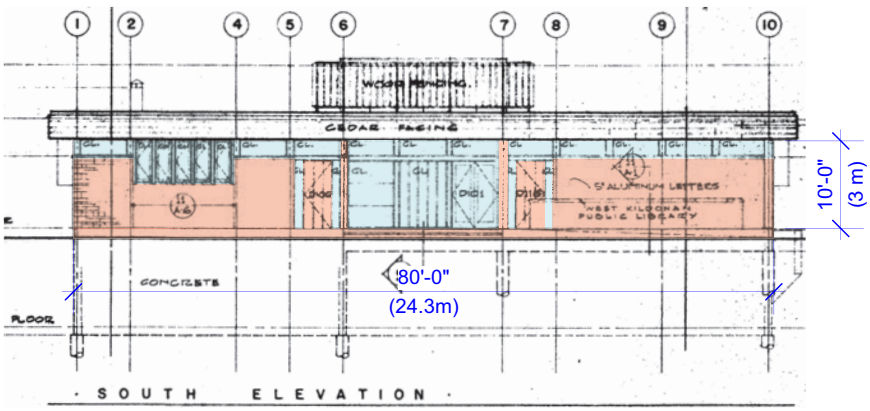
South Elevation:
Exposing Building Face: 82 sqm
Unprotected Openings: 34 sqm
% of Unprotected Openings: 41%
Ratio = 8.1 : 1

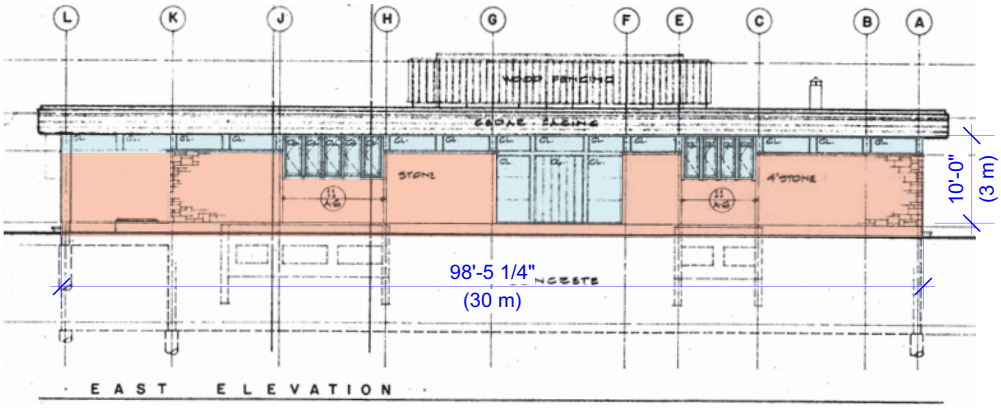
East Elevation:
Exposing Building Face: 106 sqm
Unprotected Openings: 34 sqm
% of Unprotected Openings: 32%
Ratio = 10 : 1

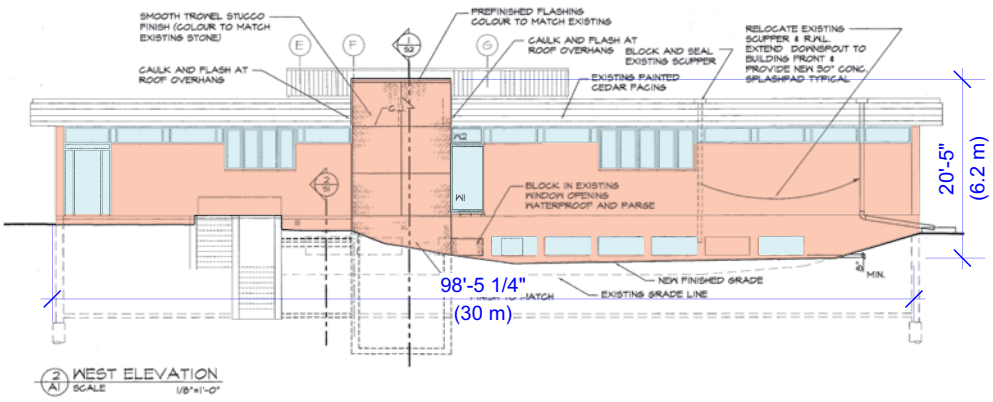
West Elevation:
Exposing Building Face: 130 sqm
Unprotected Openings: 33 sqm
% of Unprotected Openings: 25%
Ratio = 4.8 : 1

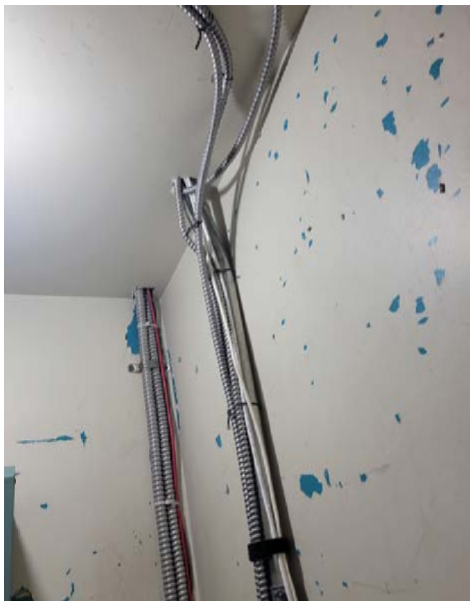
Fire Separation - Non-Compliant Condition
Janitor Room

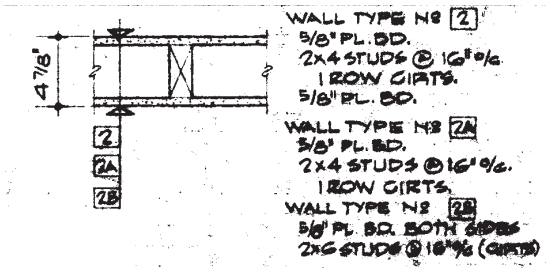
Fire-Resistance Rating of Janitor Room Walls:

Typical Interior Wall: Equivalent Assembly:
ULC W301 (or NBC type W1d - Table 9.10.3.1.-A)
Total Fire-Resistance Rating of assembly: **1 hr**

Note: this is the most equivalent tested assembly available. This assembly requires that Type 'X' gypsum board must be installed on both sides of the assembly. It is unlikely that this was installed (or available) in 1967. To ensure the required rating is provided where required, the existing plaster board should be replaced with 5/8" Type 'X' gypsum board.

Recommendations: The walls (below the transom windows) and the ceiling of the janitor room could be modified to provide a 45 minute fire separation. The existing plaster board could be removed and Type 'X' gypsum board installed to ensure this requirement is met. The door should be replaced with a fire rated door and frame. All penetrations should be firestopped. In the meantime, cleaning supplies could be stored elsewhere to reduce the risk of fire spread.

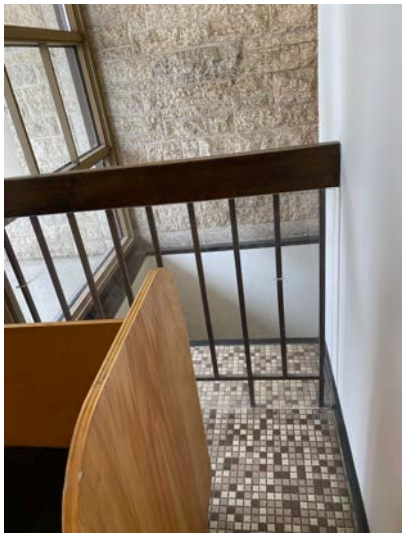
Height of Handrail - Too Low

Handrail Not Continuous on Landings
Handrail Too Close to Wall

Recommendations: The exterior handrails at the stairs and ramp should be replaced with code compliant handrails. The existing interior handrails are heritage protected. An additional code compliant handrail could be installed above the existing wood handrails at the stairs - however this solution would need to be approved by heritage review. Refer also to the handrail analysis in Part 9.

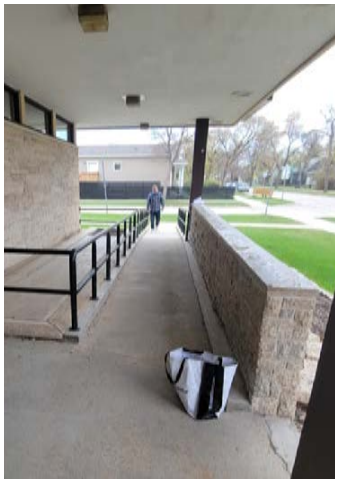
Height of Handrail/Guardrail
Too Low

Handrail is not Full Length of Stair,
No Horizontal Extensions,
Stair Rise Too High / Not Uniform

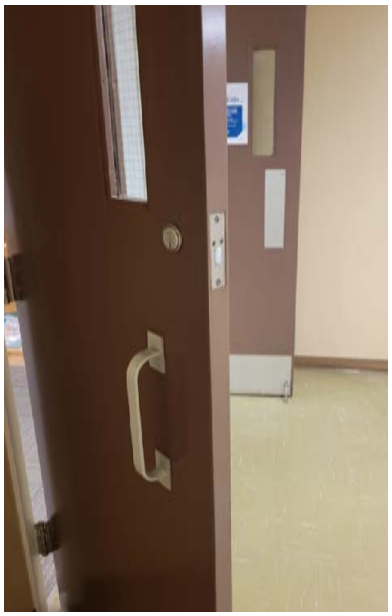
Basement Front Stair Door
D-Pulls & Push Plates

Basement Front
Stair Door -
Deadbolt Lock

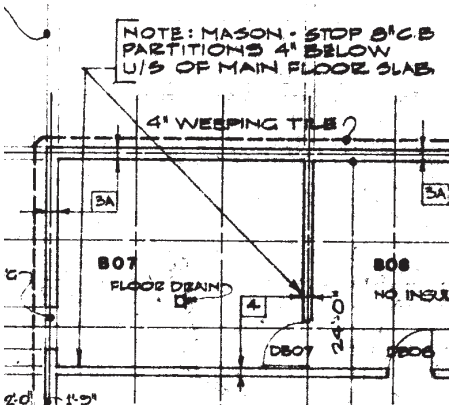
Fire Separation - Non-Compliant Condition
Boiler Room B-07

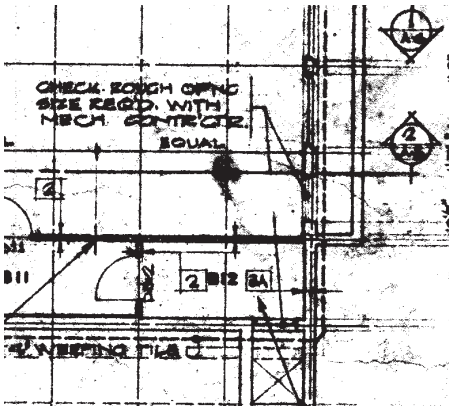
Fire Separation - Non-Compliant Condition
Mechanical Room B-12

Note: this is the most equivalent tested assembly available. This assembly requires that Type 'X' gypsum board must be installed on both sides of the assembly. It is unlikely that this was installed (or available) in 1967. To ensure the required rating is provided where required, the existing plaster board should be replaced with 5/8" Type 'X' gypsum board.

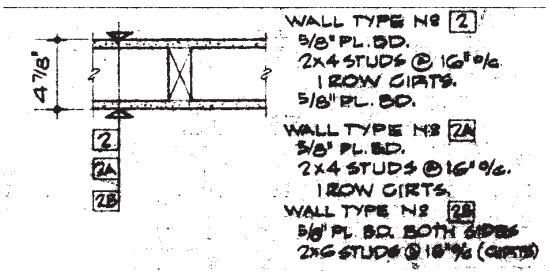
Fire-Resistance Rating of Mechanical Room Walls:

Typical Interior Wall: Equivalent Assembly:
ULC W301 (or NBC type W1d - Table 9.10.3.1.-A)
Total Fire-Resistance Rating of assembly: **1 hr**

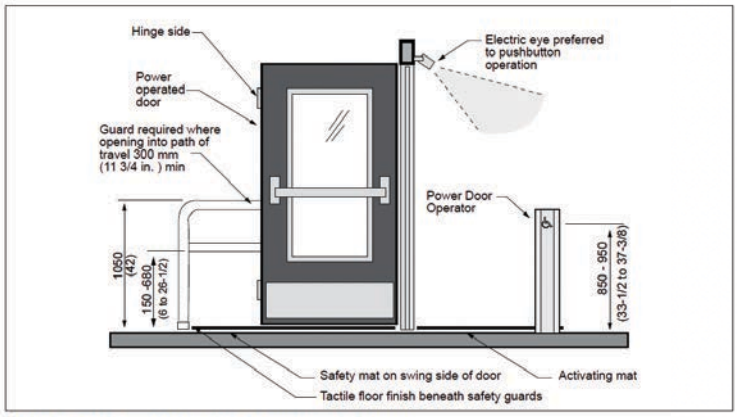
Hallway 111
Insufficient Space on Pull Side of Doors

Recommendations: Most existing doors and frames would need to be replaced (and rough openings widened) to comply with this article, which may not be feasible or approved by heritage review. Since this is a retrofit situation, it may be permitted to leave these doors in place. Some door hardware (knobs) need replacement. Kick plates could be added. Doors and frames could be painted to improve colour contrast. A power door operator could be added at the UTR and at doors across primary circulation routes. The entrance operator buttons could be replaced. Where maneuvering space can't be provided on the push or pull side of existing doors, a power operator could be added.

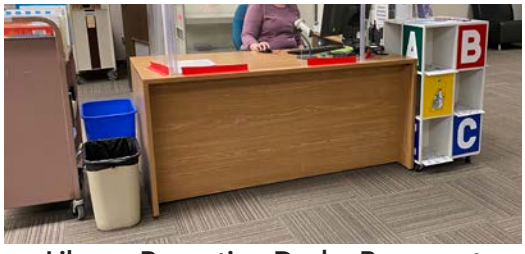
Risk to occupant safety: **Low.** This condition presents little risk to occupants, but reduces the accessibility of the space. Those in a wheelchair cannot properly access the reception counters.

Library Reception Desk - Basement

Recommendations: The existing millwork would need to be replaced or modified to comply with this article.

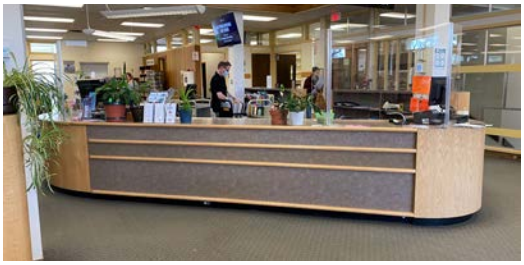
Library Reception Desk - Main Floor

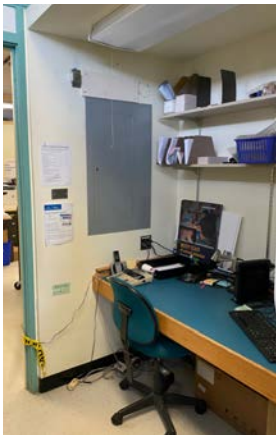
Risk to occupant safety: **Low.** This condition presents little risk to occupants, but reduces the accessibility of the space. Those in a wheelchair cannot properly access the work surfaces.

Fixed Work Surfaces

Recommendations: The existing millwork would need to be replaced to comply with this article.

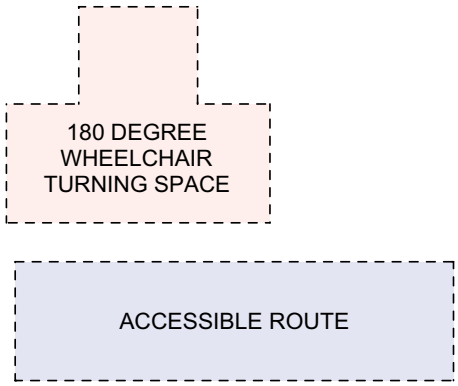
Analysis: WADS states that "if it is technically infeasible to have all offices accessible, at least 25% of the total offices within a floor area shall meet the requirements of this section". WADS requires that offices shall "incorporate a clear space allowing a person in a wheelchair to make a 180 degree turn (See figure 1.1.1.5); and incorporate an accessible route through the space that does not require the person in a wheelchair to travel backwards to enter/leave the space".There are 3 office spaces in the library: Room 108, Room 112, and B-18. To be compliant with WADS, at least one of the offices on the main floor and in the basement must be accessible. On the main floor, Office 112 has the accessible clearances, but Hallway 111 (leading to this office) does not qualify as an accessible route. Office 108 has adequate clearances for accessibility. The only basement office, Room B-18, does not have the required clearances to be accessible, so the building is not compliant with WADS.

Risk to occupant safety: **Low.** This condition presents little risk to occupants, but reduces the accessibility of the space. Those in a wheelchair cannot properly access the basement offices.

Analysis of Offices (for Accessible Clearances)

Recommendations: An alternate, accessible office could be provided elsewhere in the basement.

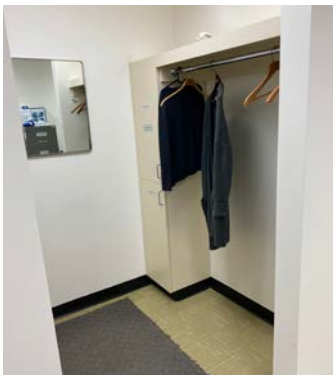
Risk to occupant safety: **Low.** This condition presents little risk to occupants, but reduces the accessibility of the space. Those in a wheelchair cannot properly access the closet.

Staff Room Closet (Rm B-17)

Recommendations: The existing millwork/rod could be replaced or modified, or a lower shelf and rod could be added.

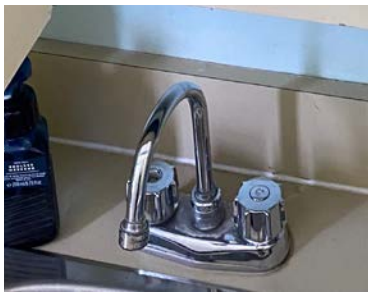
Risk to occupant safety: **Low.** This condition presents little risk to occupants, but reduces the accessibility of the space. Those in a wheelchair cannot properly access the kitchenettes.

Receiving Room Sink (113)

Recommendations: The existing millwork, the sink in Room 113, and the fridge in Room B-17 would need to be replaced or modified to comply with this article.

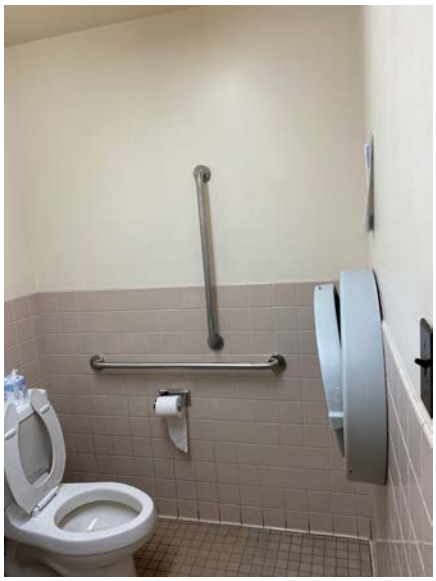
The grab bars in Room 104 comply with Figure 3.3.3.1. However, there is no horizontal grab bar on the wall behind the toilet, which is not WADS compliant. See the analysis of Section 3.3.8. The toilet-paper dispenser is wall mounted, is close enough to the toilet, is located below the grab bar, and is not less than 600mm above the floor. However, the dispenser is not located in front of the toilet seat, so it is not compliant with WADS. The toilet paper dispensers in the remaining washrooms were not assessed, since these washrooms are not accessible.

Washroom 104
Grab Bars, Baby Change Table

Recommendations: In Room 104, a horizontal grab bar could be added behind the toilet. The tank lid could be replaced with a locking model. The location of the toilet paper dispenser and garbage bin could be adjusted.

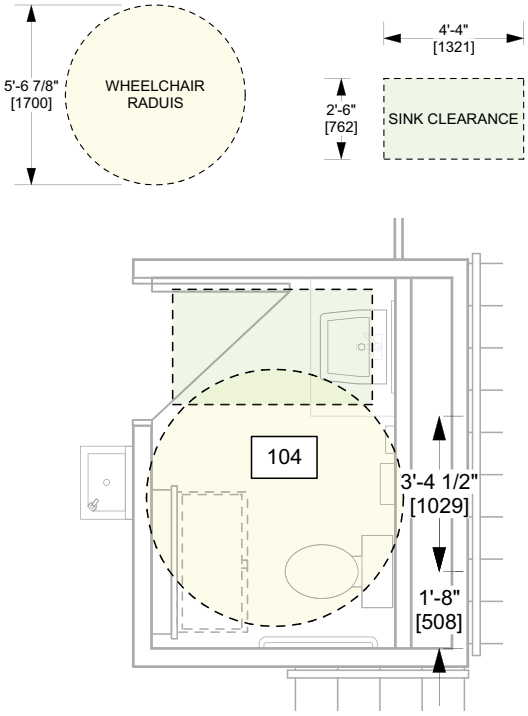
Risk to occupant safety: **Medium.** This condition reduces the accessibility of the space. Those requiring a change bench and those in a wheelchair cannot properly use the existing UTR. There is a risk that if an occupant were to slip and fall inside the UTR, there is no call button to alert staff.

Analysis of Room 104 (UTR)

Recommendations: A UTR would need to be added on the basement level to comply with this article. Washroom 104 could be widened / reconfigured to better comply with WADS. The room would also need to be widened to add a fold-down or stationary adult change bench. However, this would reduce the width of the exit. Refer to the analysis and recommendations for Exits in Part 7 for further information.

The length of the vanity could be reduced to provide more space between the vanity and the toilet. The door hardware could be replaced with a lever style handle. An emergency call button could be added to this room.

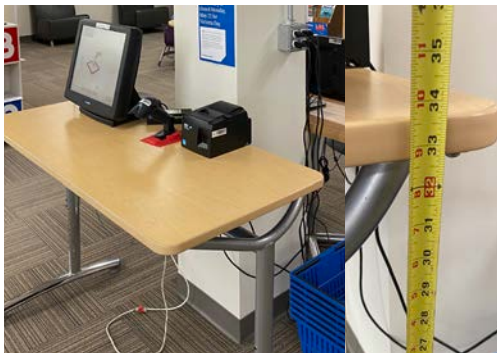
Risk to occupant safety: **Low.** This condition presents little risk to occupants, but reduces the accessibility of the space.

Basement - Checkout

Recommendations: Accessible workstations could be added or could replace existing workstations. Height adjustable tables could be added. The existing library stacks could be replaced (if they are not heritage protected items). The location of stacks should be adjusted if the 1100mm aisle requirement is not met. The height of the book slots could be adjusted. The book slot could be relocated (or the washroom size adjusted) to provide the clear platform required in the north entrance. Headphones should be provided for public use at the audio rentals, or a separate, acoustically separated space could be provided for listening.

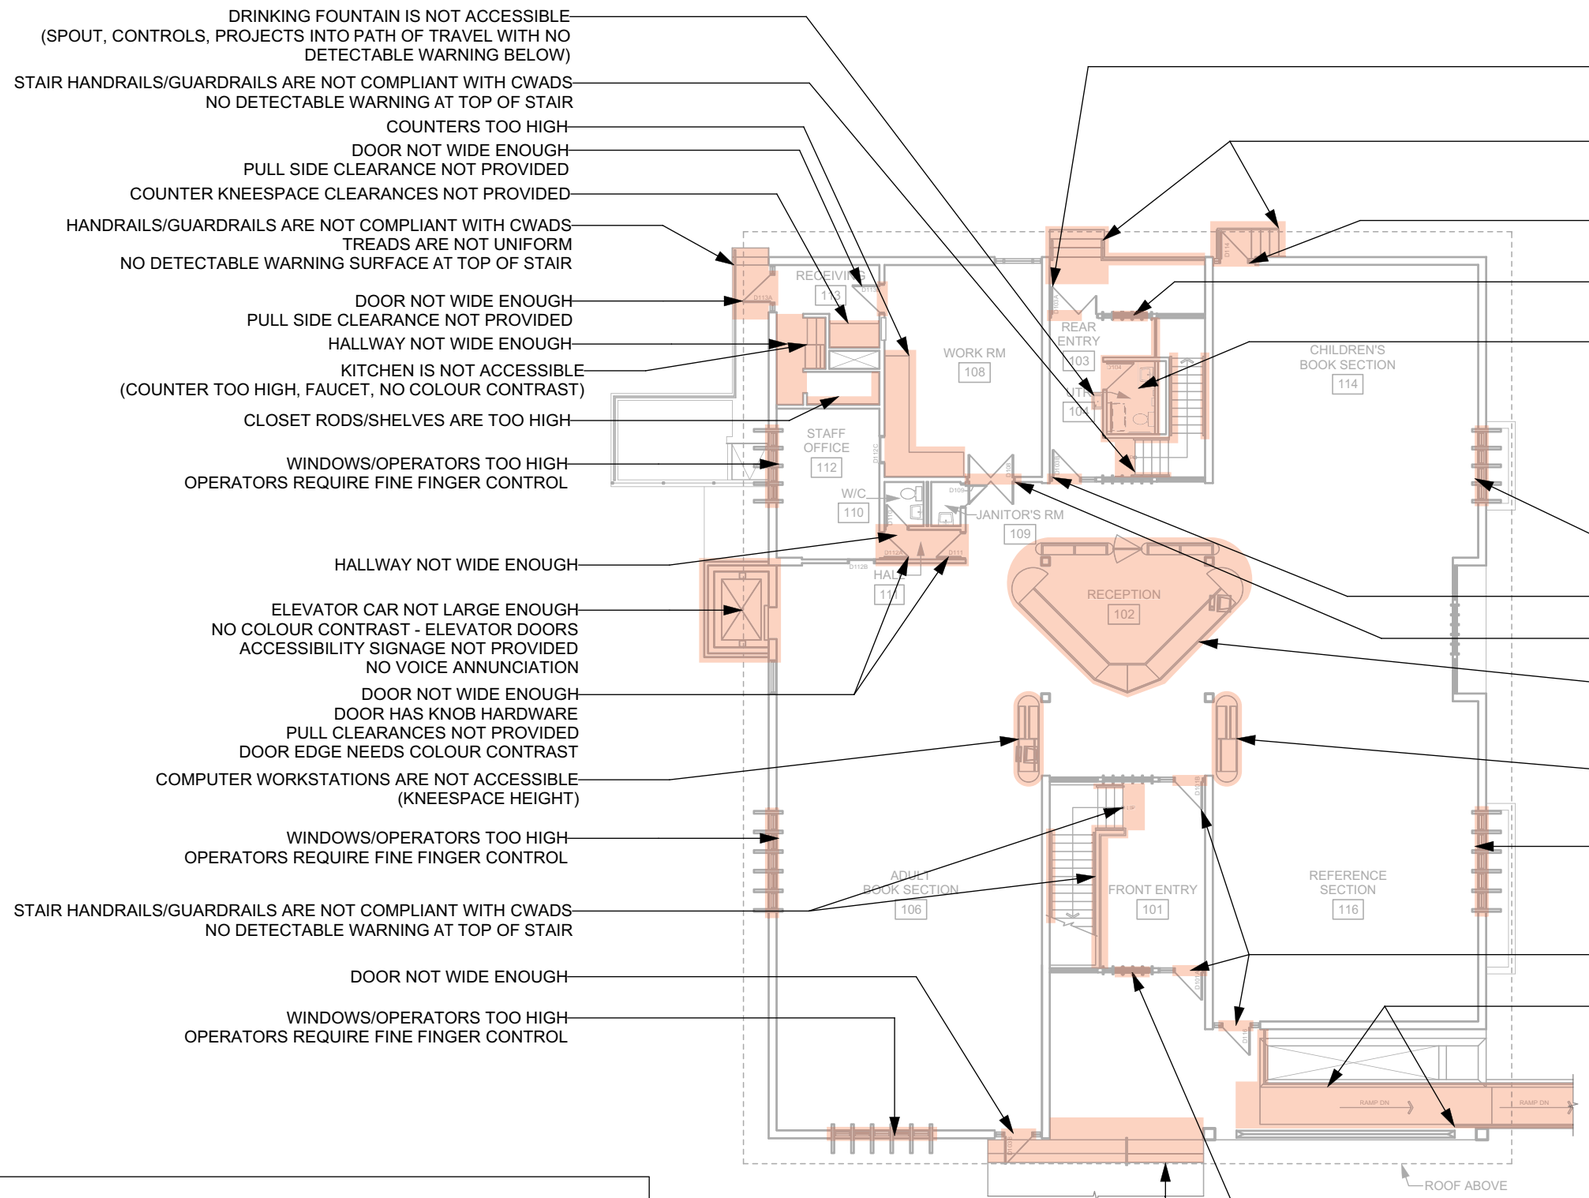
DRINKING FOUNTAIN IS NOT ACCESSIBLE
(SPOUT, CONTROLS, PROJECTS INTO PATH OF TRAVEL WITH NO DETECTABLE WARNING BELOW)

Recommendations: The drinking fountain could be replaced with an accessible model. A warning surface could be added below the fountain, or the fountain could be relocated so it does not project into the accessible route.

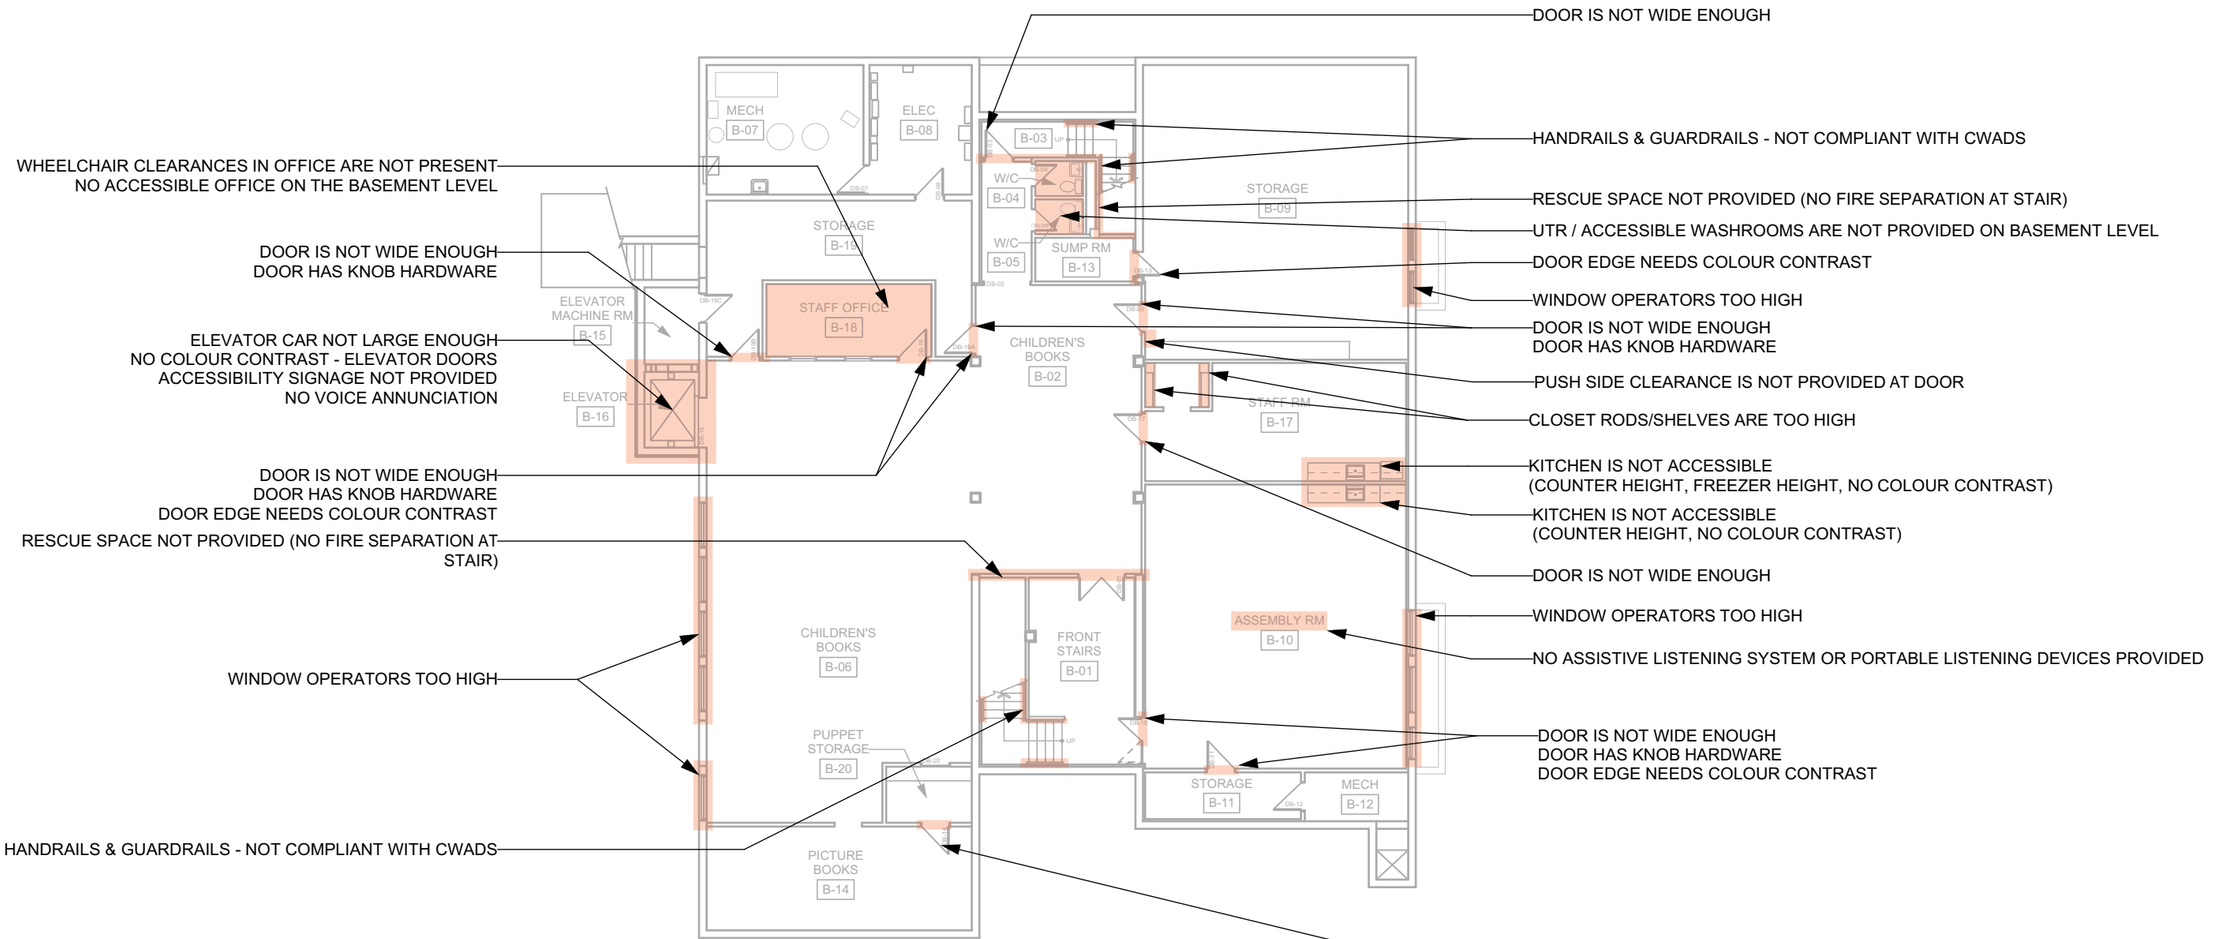
1 BASEMENT FLOOR PLAN - ACCESSIBILITY ISSUES
Scale: 1:200

GENERAL NOTE:
- HEIGHT OF CONTROLS (LIGHT SWITCH, THERMOSTAT, FA PULL STATIONS, ETC.) IS NOT COMPLIANT IN MANY LOCATIONS THROUGHOUT THE BASEMENT LEVEL
- ROOM SIGNAGE IS NOT CWADS COMPLIANT THROUGHOUT
- PROLIFERATION OF SIGNAGE CREATES CONFUSION THROUGHOUT

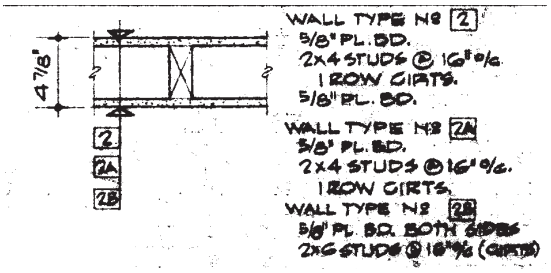
STC Rating of Interior Walls:

Typical Interior Wall: Equivalent Assembly:
ULC W301 (or NBC type W1d - Table 9.10.3.1.-A)
STC rating of assembly: **32**

Note: this is the most equivalent tested assembly available. This assembly requires that Type 'X' gypsum board must be installed on both sides of the assembly. It is unlikely that this was installed (or available) in 1967. To ensure the required STC rating is provided where required, the existing plaster board should be replaced with 5/8" Type 'X' gypsum board.
