WEST KILDONAN LIBRARY

BUILDING CONDITION ASSESSMENT, HERITAGE ASSESSMENT, CODE COMPLIANCE REVIEW, & FEASIBILITY STUDY

Winnipeg, Manitoba
March 2024

Prepared for:
The City of Winnipeg

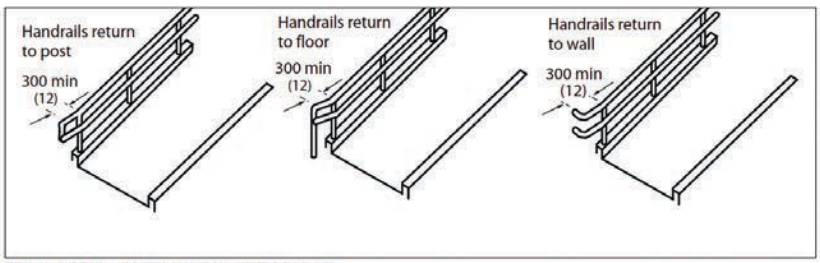
The distance from the interior stair handrail to the smooth wall surface behind is 1-3/8" (35mm). This is too close - it is not WADS compliant.

Risk to occupant safety: **High.** See the WADS risk analysis and recommendations for stairs and ramps. Refer to the recommendations provided in Part 7 for handrails.

Interior Handrail
